The Dieweg Fire

Presentation:
Karel Lambert - Brussels Fire Department

Version 0.2
14/03/2011

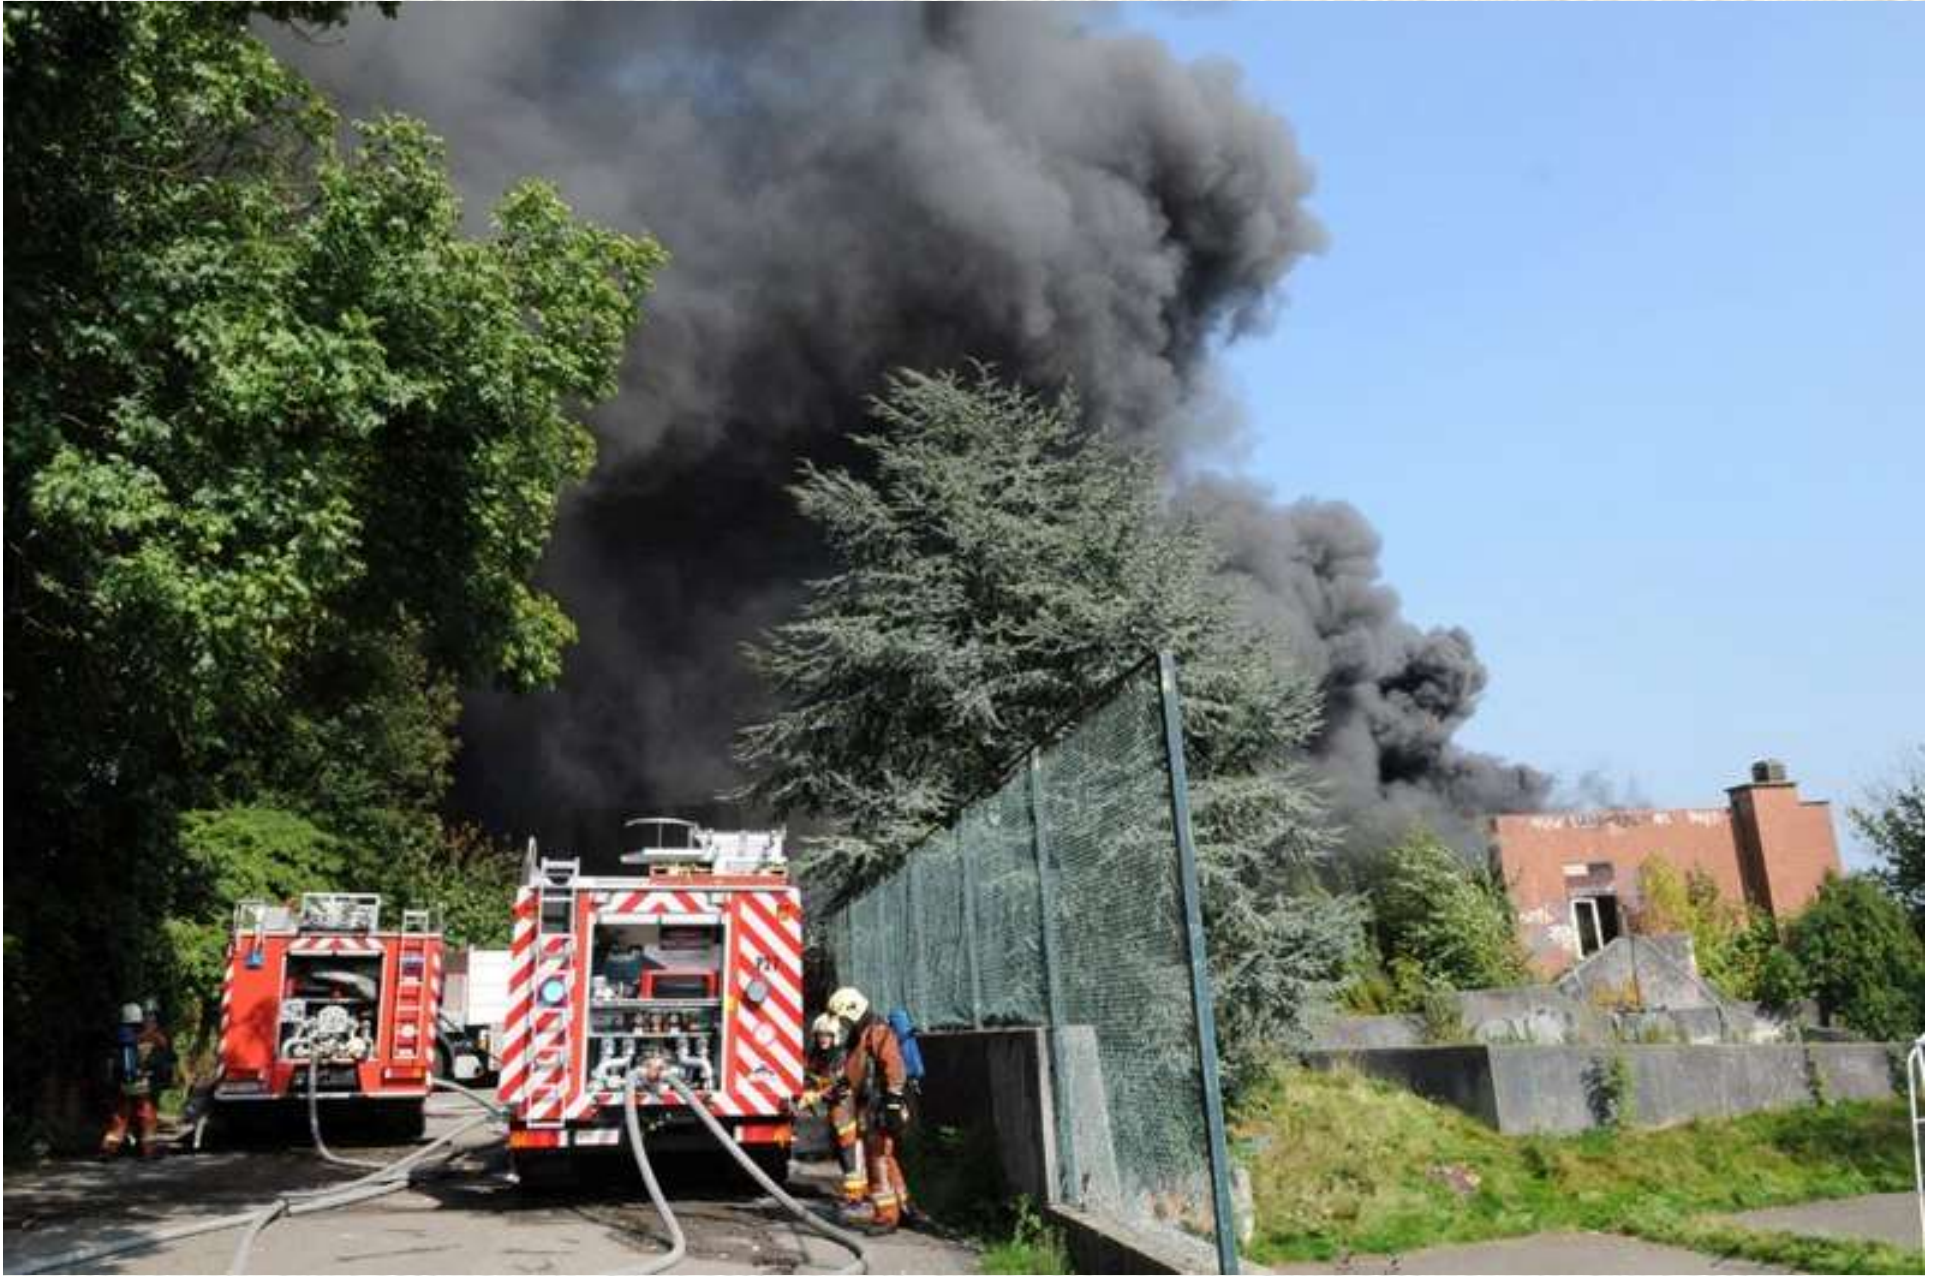
ASSUMPTIONS

- Building A is on Fire
- There is a park between building A and building B
- The trees and the bush in the park are on fire
- The wall that can be seen through the smoke is the wall that separates the park from the adjacent property
- The buildings have 2 floors and a flat roof

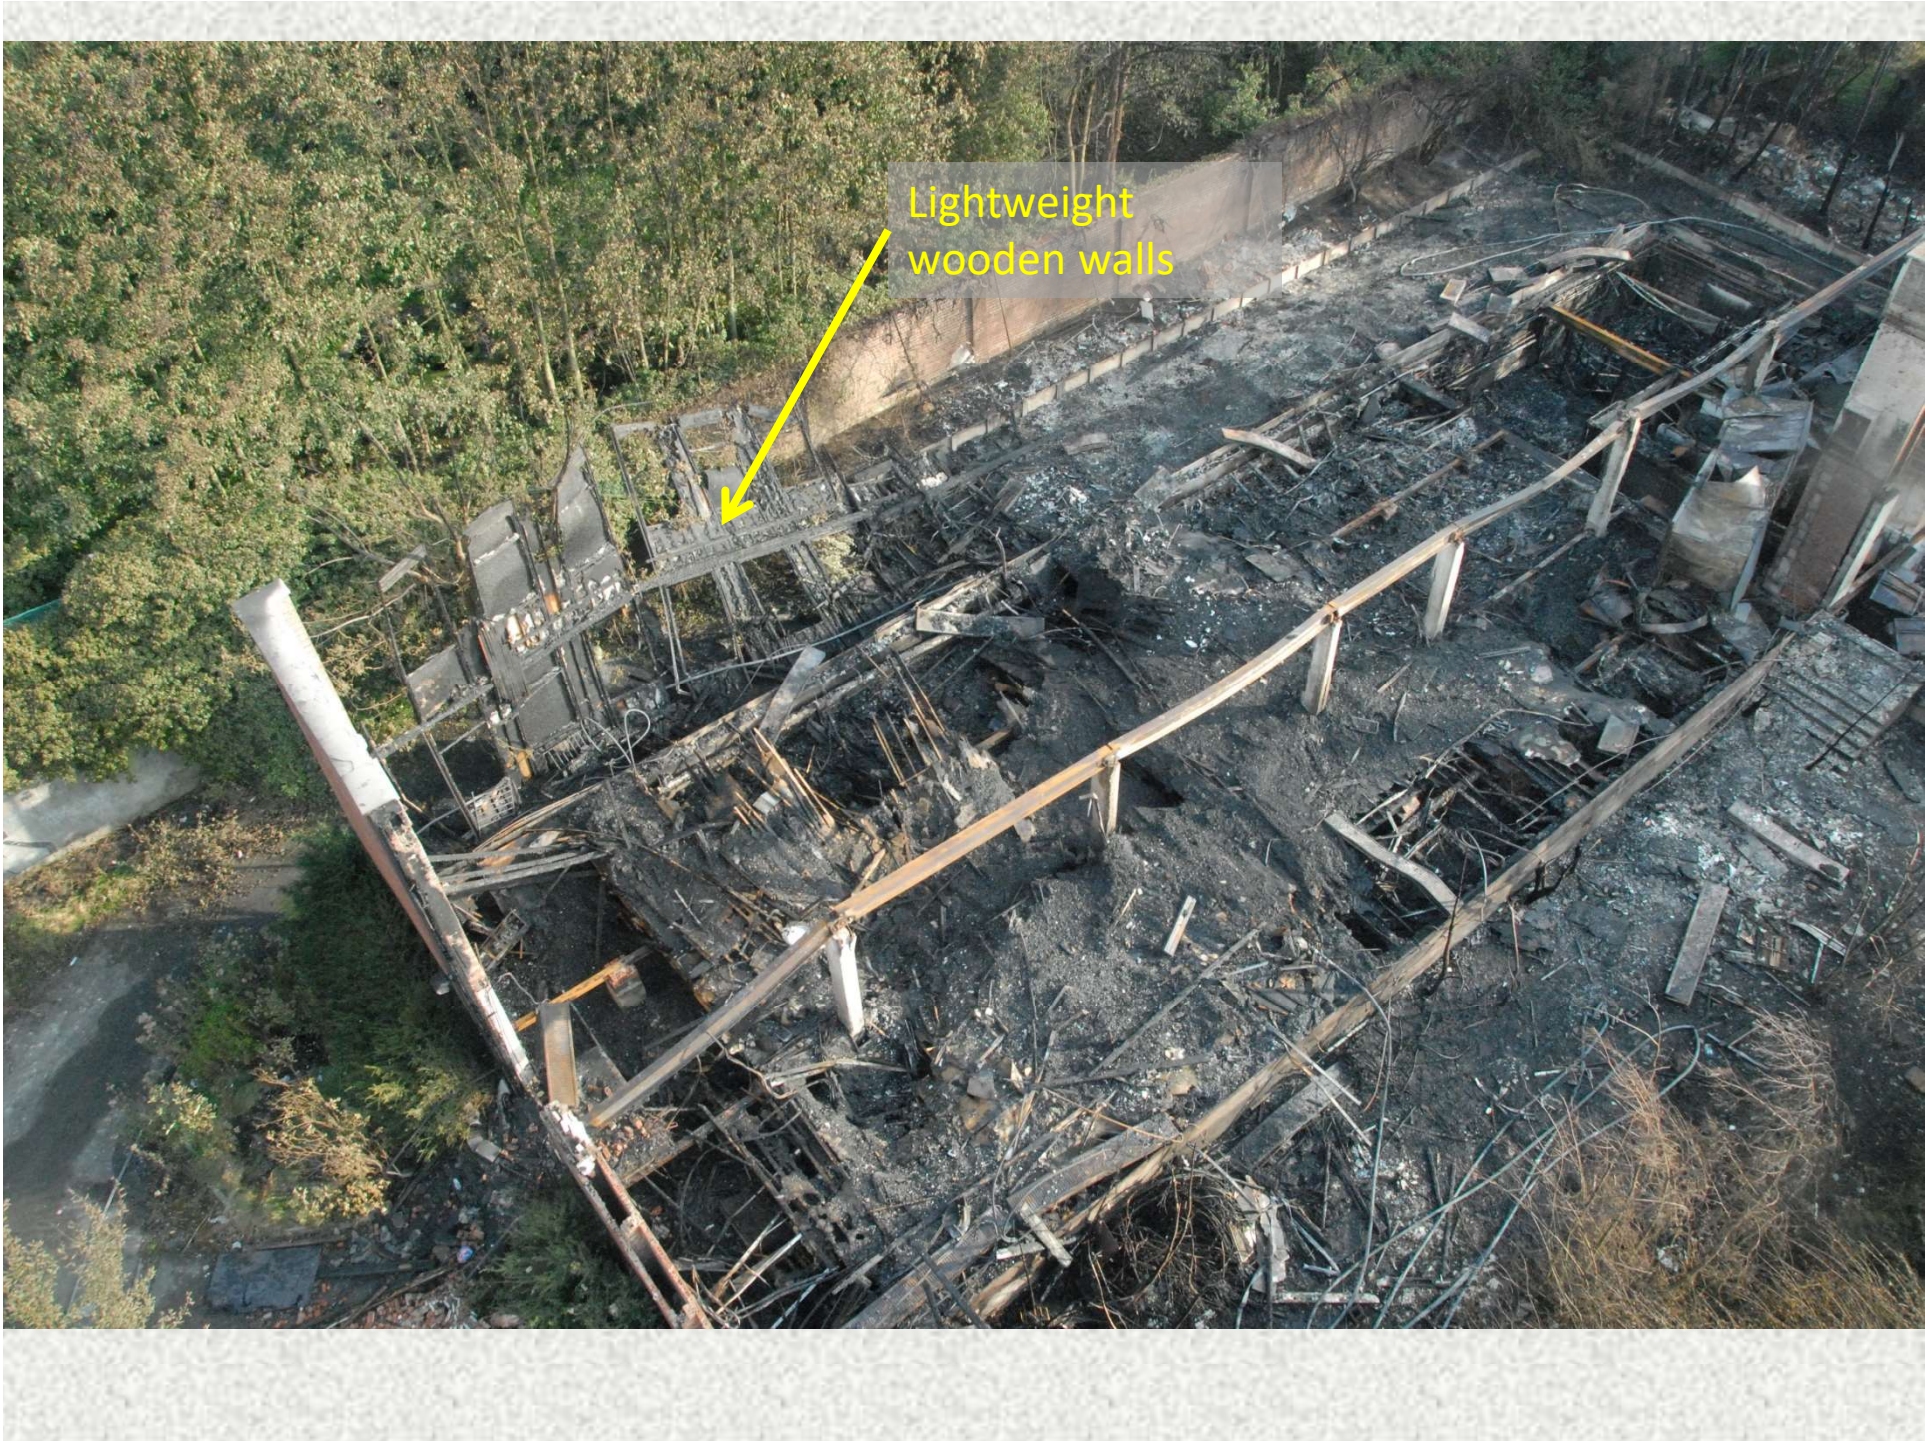
Lightweight
wooden walls

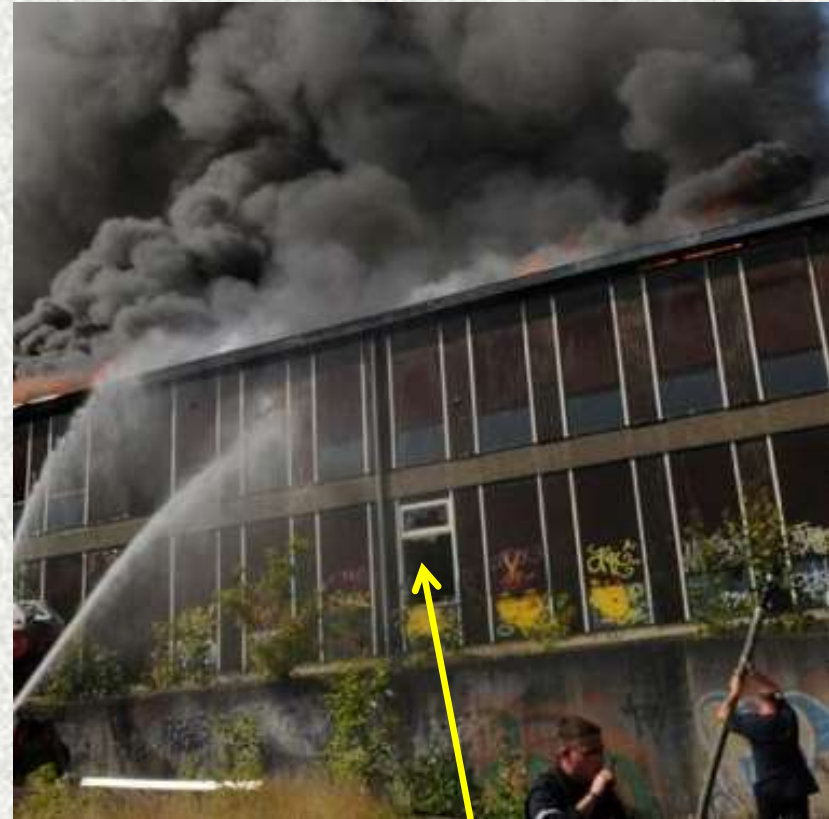
Entry to building made by squatters

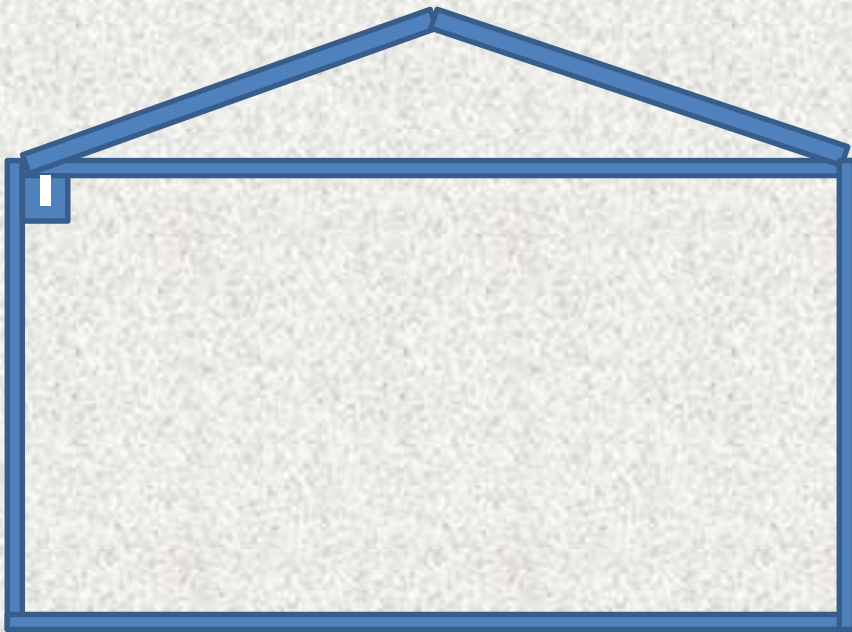
This is a mousetrap!

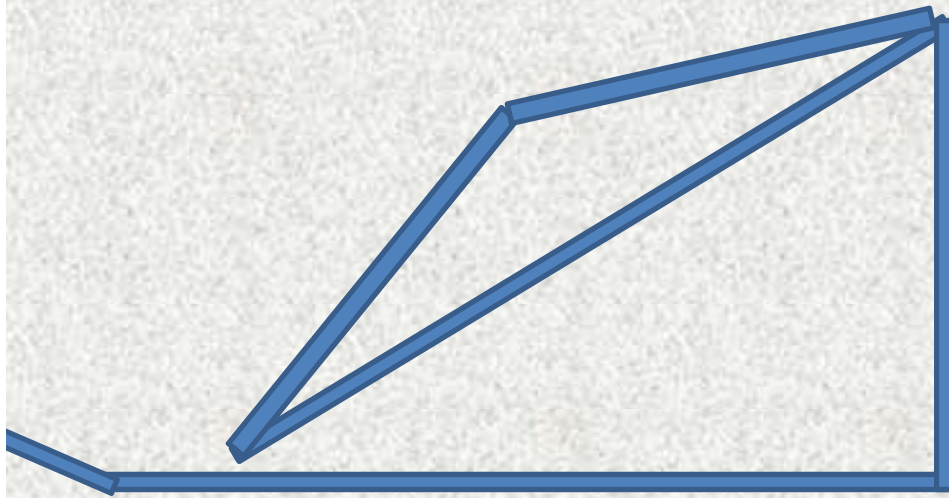
The way the building was constructed was an unknown element.

Such buildings exist. There is nothing we can do to eliminate this “fact”.

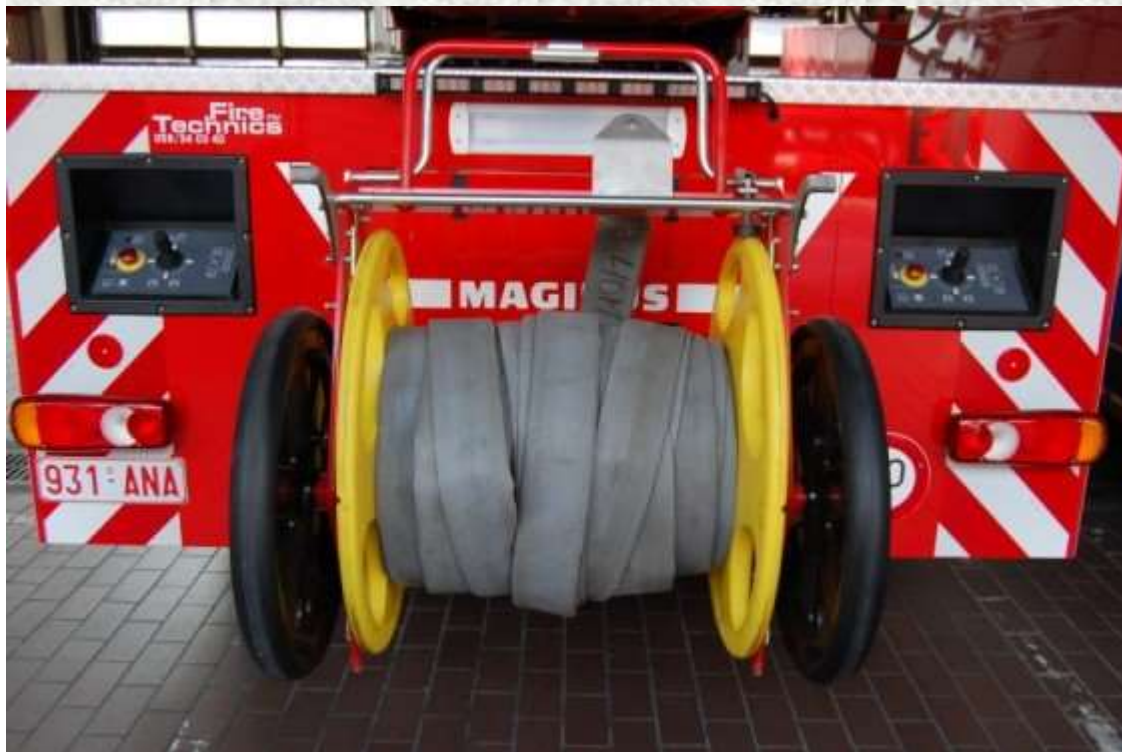
1 exception:
hose reel (weight)

- The length of the hoses on the reel was brought to 120 m after the fire.
- New, lighter reels were placed on the ladders.
- Extra hoses were added to the ladder trucks for long distances.

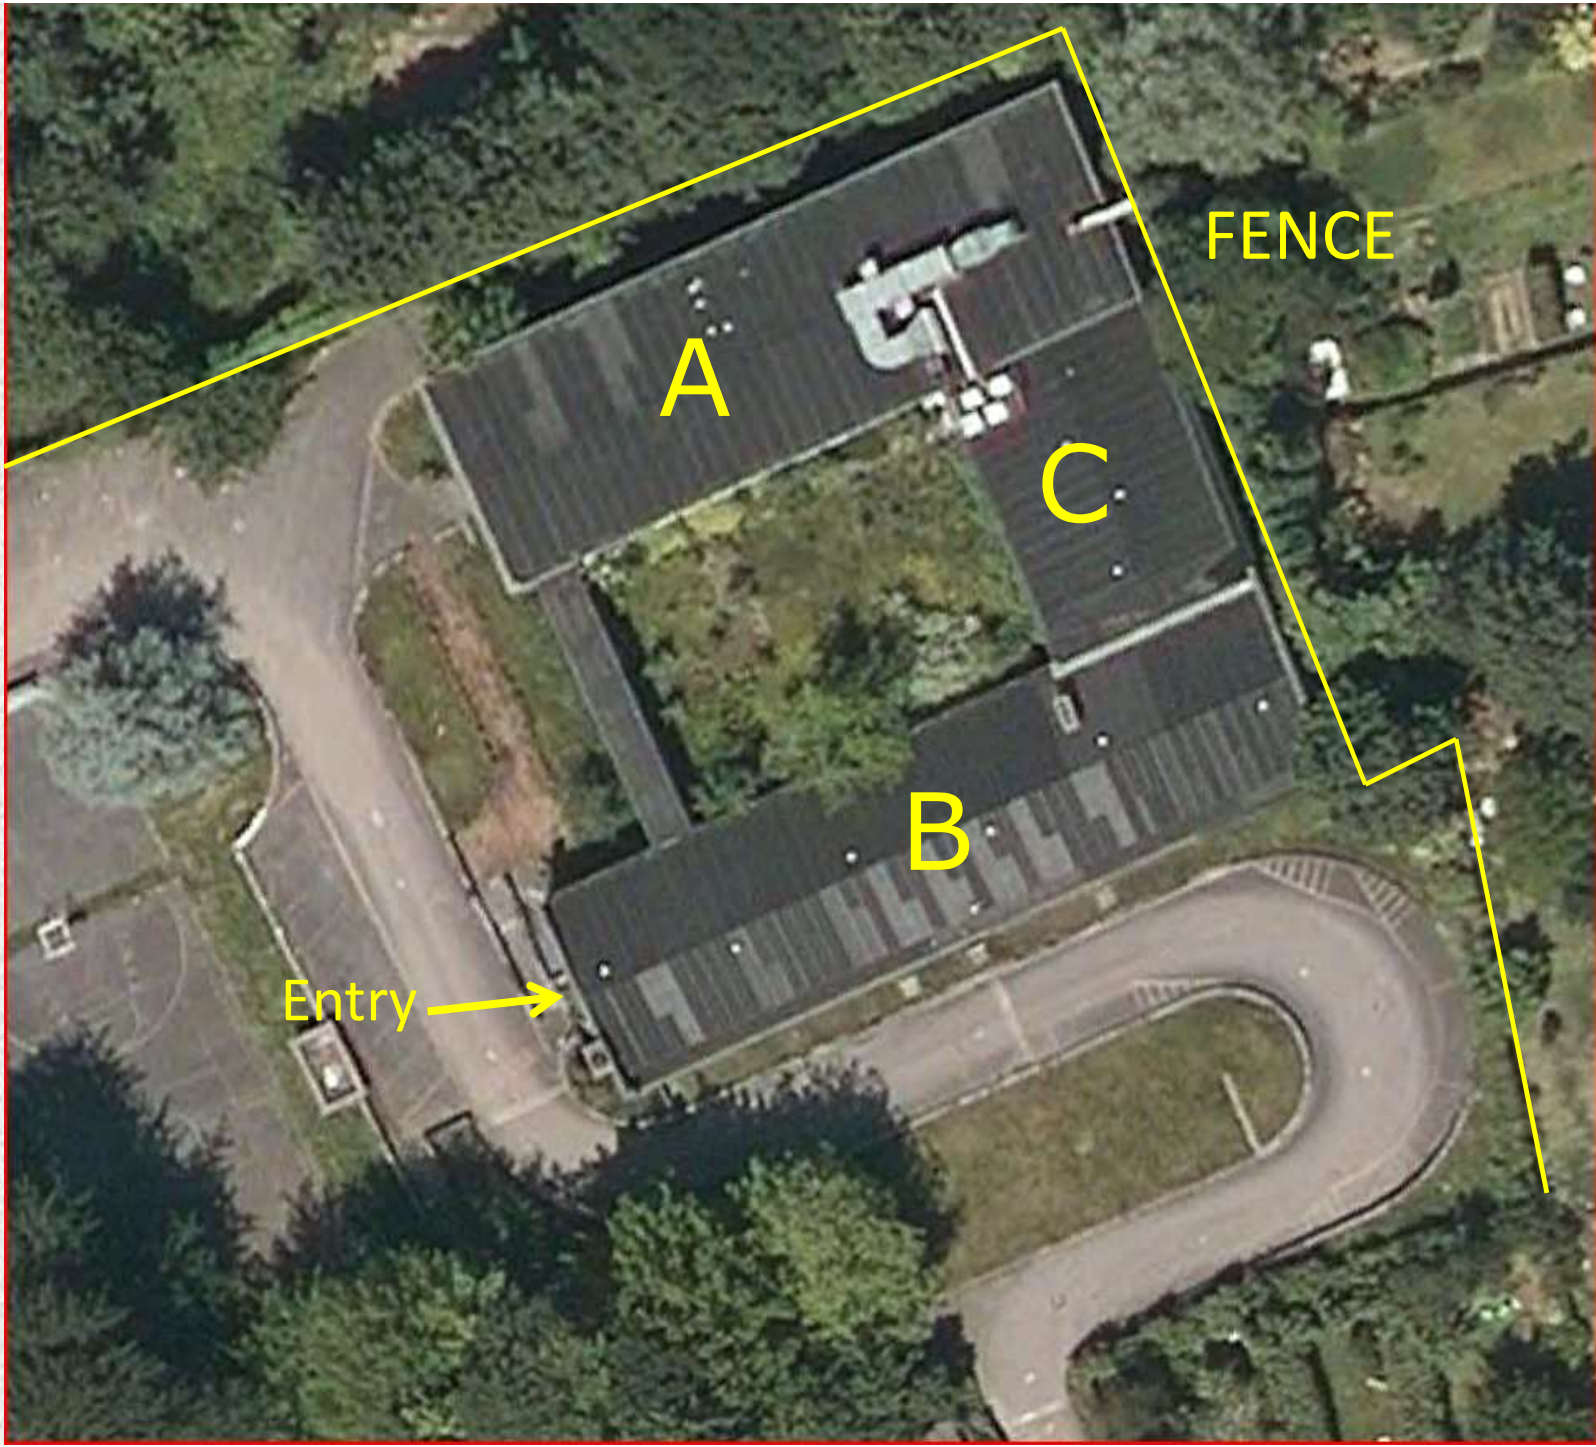
- Attack via side bravo was impossible due to the heat.
- Side charlie could only be reached through the garden of the neighbours.
- The difference in height (4 m/ 13ft) made it very difficult to enter via side delta.
