# Construction Fire In Brussels: Smoldering fire of polyurethane

## 1 Introduction

## 2 Call for suspicious smoke in Brussels

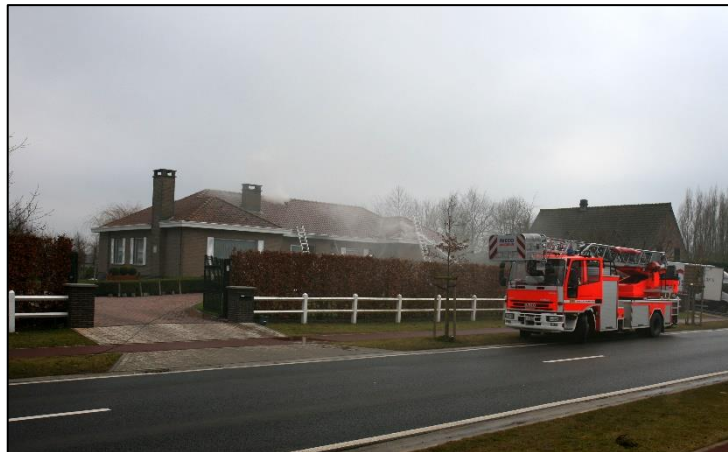
The Fire Department was sent to a detached one-family-building (Image 1). All rooms in the building were situated at ground floor level. On top, there was an unused attic space underneath a pitched roof.

The building was renovated before. A new roof (structure + covering) was placed on top of the existing roof.

At this moment, new construction works were executed. In the attic, isolation in polyurethane (PUR) was sprayed between the rafters of the structure of the second roof. By isolating the attic in a better way, the house would consume less energy. Spraying PUR is an exotherm process. The construction workers have to respect a set of rules to ensure the heat, which releases with the formation of PUR, is being extracted. During these works, a small fire started. The workers were able to extinguish it themselves. However, they did not contact the Fire Department to check if their extinguishing was effective.

**Image 1** Detached building with living rooms at ground floor level and unused attic space underneath the rooftop. (Picture: JVK)

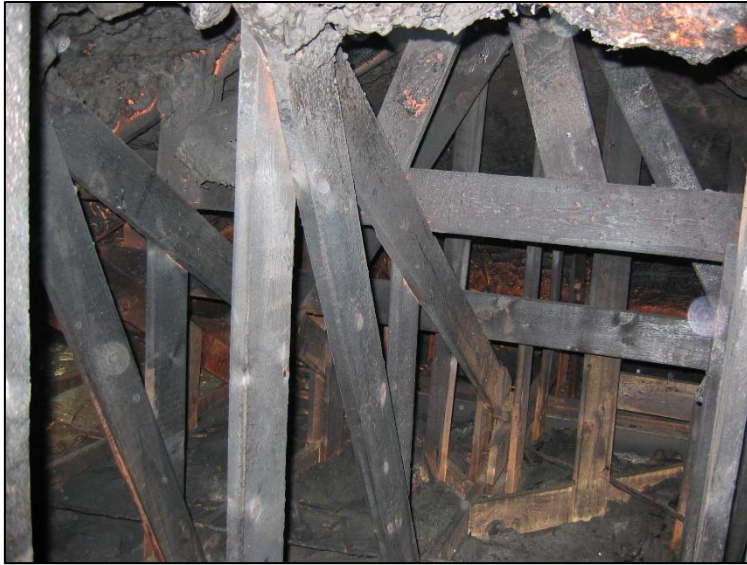
The attic is a non-usable space. A network of wooden rafters supports the roof. This causes only a narrow space to pass through. This sure is detrimental for persons carrying SCBA, who cannot easily pass through tight spaces.

**Image 2** The wooden support structure on the attic. The space between the rafters was rather limited. Because of this, the liberty of moving for the firefighters carrying SCBA was limited as well. (Picture: Diksmuide Fire Department)

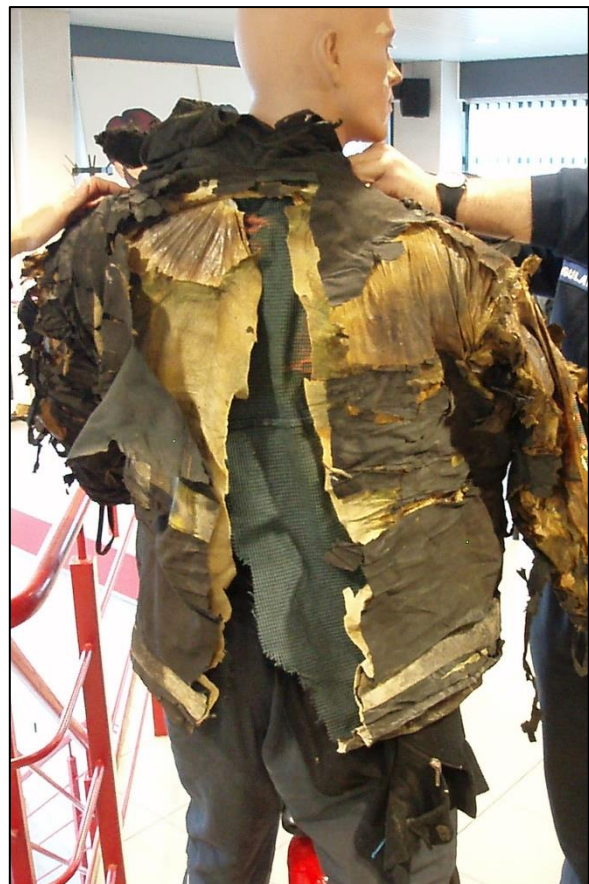
Both firefighters suffer severe burn injuries. Their protective clothing and SCBA is very heavily damaged. There is no doubt that they survived this because of their professional attitude: Without their breathing apparatus masks, they would not have stood a chance.

**Image 3** The protective clothing of one of the firefighters after the fire. (Picture: Diksmuide Fire Department)

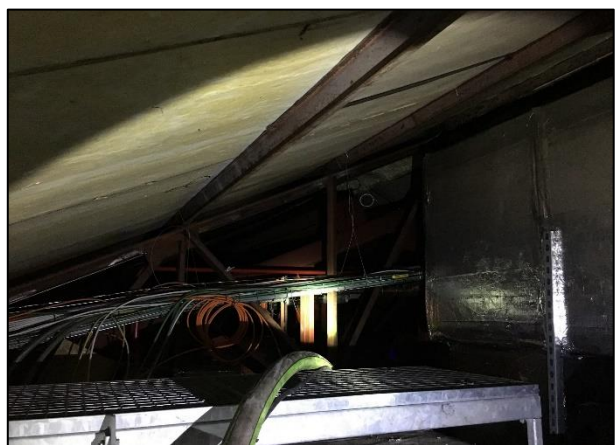
Above all, the entrance to the attic is very limited in space. Two entrance ladders/stairs are used to enter the attic from the floor below. Furthermore, the presence of large ventilation shafts on a specific place on the attic force firefighters

**Image 6** This picture shows the access to the attic. Only 50 cm allow to pass into the attic. For a SCBA-wearer this is a very limited space. (picture: Nicolas Freuville)

to proceed through a very narrow opening to enter or leave the attic.

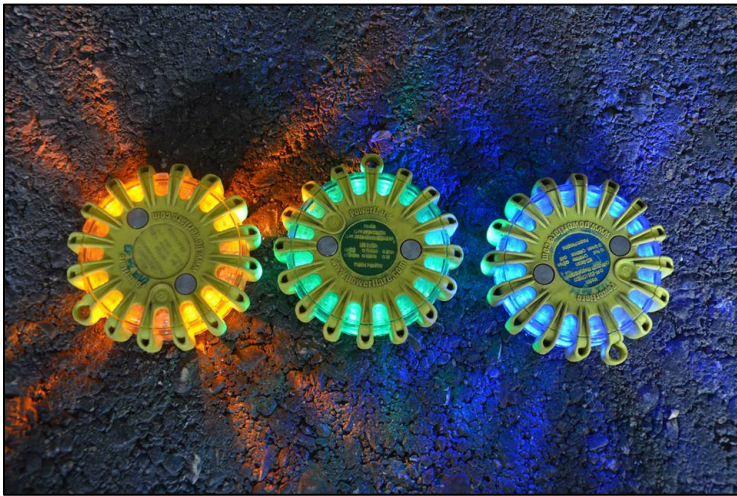
**Image 7** A yellow, a green and a blue PUC in action. (Picture: Jean-Paul Heyens)

Meanwhile, the suggestion is made to place green PUC's at the inside which can indicate the way out (conform the recommendation of the learning commission *Beringen*). If suddenly smoke would be produced, firefighters can easily find their way out by following the lights (See image 7). Major Lambert decides around 14h50 to ask for a 3<sup>rd</sup> engine on scene to be sure to have the necessary units if the situation would develop.

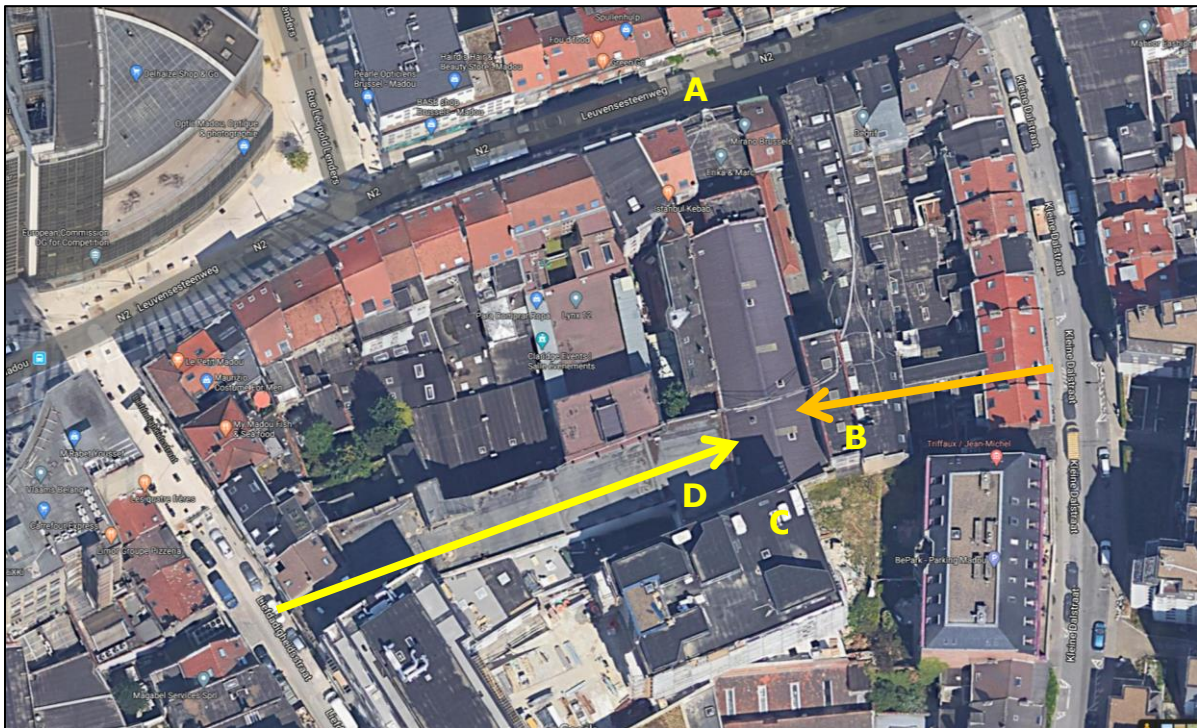
**Image 9** The Brussels Fire Department finds two entries to the roof of the *Mirano*. Major Jalet finds an acces via a building in Kleine Dalstraat (orange arrow). Captain De Paepe's team finds an acces via Liefdadigheidsstraat. Passing over about 100 meters of flat, connected roofs they reach the roof next to the burning building (yellow arrow). In this way, the fire was surrounded. (Picture: Google Maps)

Major Jalet and his team find an entrance via Kleine Dalstraat. He can get a view of the roof of the attic through an adjacent building on the Bravo side. The fire has spread in the meantime. The ridge is currently burning over a distance of several meters. His team breaks the glass parties in the common wall to gain access to the sloping roof above the *Mirano's* attic. (See Image 11).

Captain De Paepe is able to gain access to the Delta side of the roof via the flat roofs of buildings that reach out onto Liefdadigheidsstraat. They cover a distance of about 100 meters on those flat roofs before they reach the roof of the *Mirano*. Arrangements are made on both sides to ensure that there are two 45mm hoses on either side of the roof ready to begin extinguishing should the fire spread. These fire hoses also serve to protect the facade of the apartment building on the Charlie side. Should the roof of the attic partially collapse and a large fire would start, there would be a potential problem of fire spreading to the apartment building. The two extinguishing hoses therefore also served to cool this facade if necessary.

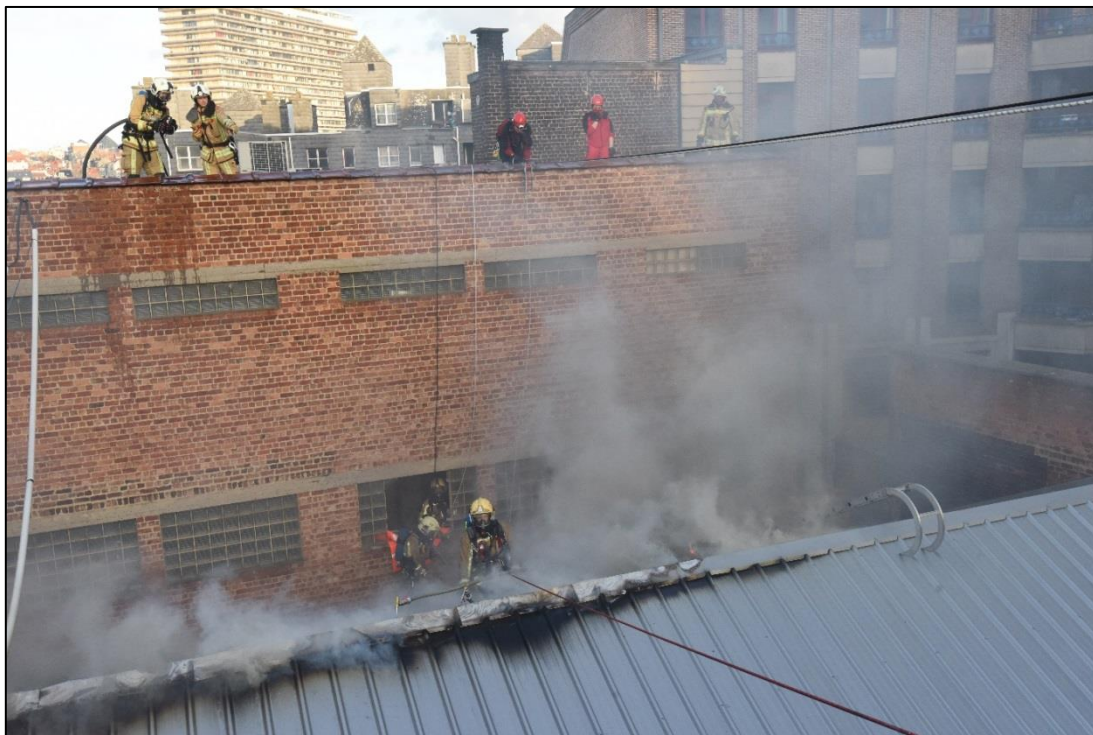
Corporal Schepens of the climbing team starts making an opening in the roof around 17h30. This is a very laborious job, under SCBA and hanging from two ropes. The construction of the roof makes this work very difficult. Finally, he manages to make an opening. From that moment on, the fire department has found a good way to fight this fire.

**Image 11** The climbing team makes an mounting with ropes to secure the works in the roof, followed by the opening of a wall with glass parties to gain easy access to the sloping roof. As a result, the firefighters can start making holes in the roof, hanging by ropes. (Picture: Robert Decock)

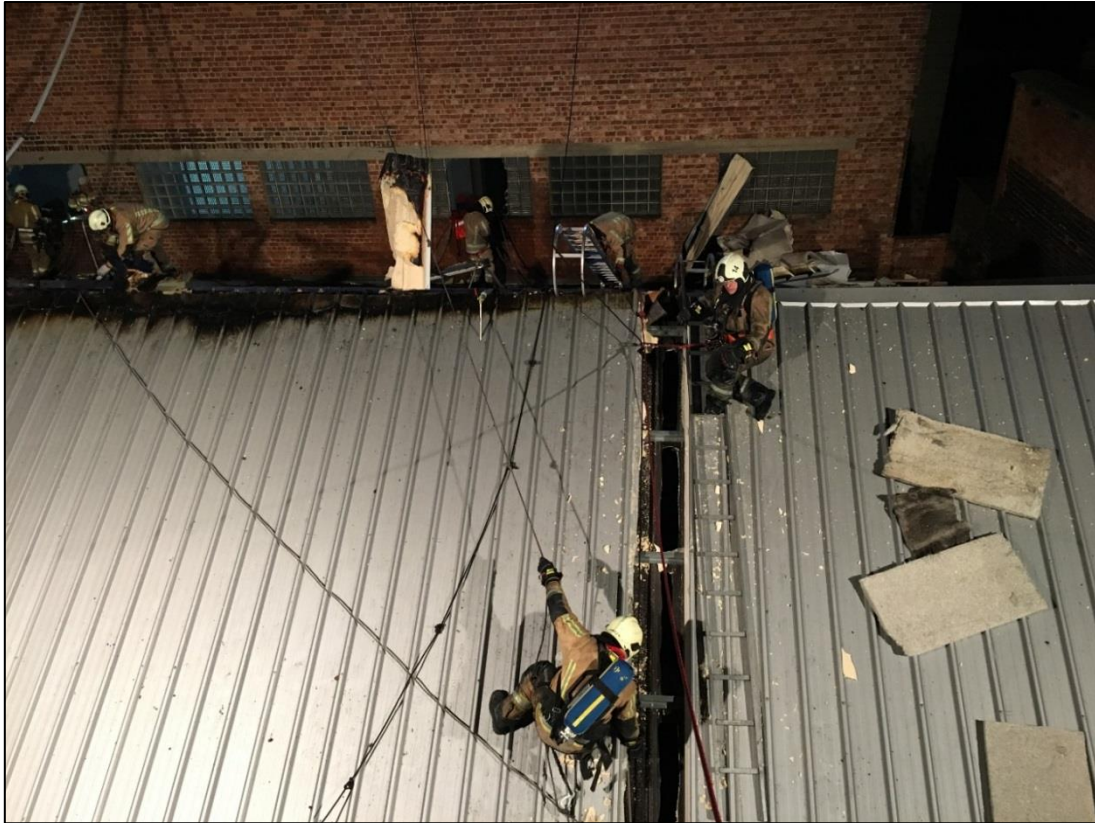
The following hours, the roof is opened further and further. The tactic exists in making trenches to ensure the smoldering fire cannot spread any further.

**Image 12** As time passed, a trench was realized. On one side of the roof a cut was made along the full length. Because of this, the fire could not move further on that side of the roof. (Picture: Nicolas Freuville)
