## Interstate Bank Building Fire Los Angeles, California

# **Interstate Bank Building Fire Los Angeles, California (May 4, 1988)**

**Investigated by: J. Gordon Routley**

**This is Report 022 of the Major Fires Investigation Project conducted by TriData Corporation under contract EMW-8-4321 to the United States Fire Administration, Federal Emergency Management Agency.**

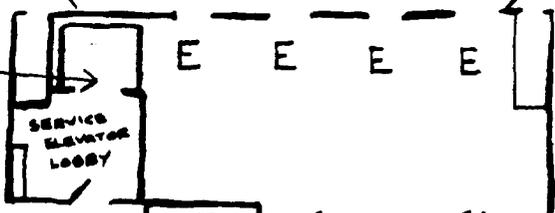
12<sup>TH</sup>  
FLOOR

The fire originated in an open-plan office area in the southeast quadrant of the 12th floor. (See Appendix A.) The area of origin contained modular office furniture with numerous personal computers and terminals used by securities trading personnel. The cause is thought to be electrical in origin, but the precise source of ignition was not determined. The fire extended to the entire open area and several office enclosures to fully involve the 12th floor, except for the passenger elevator lobby, which was protected by automatic closing fire doors.

POINT OF ORIGIN

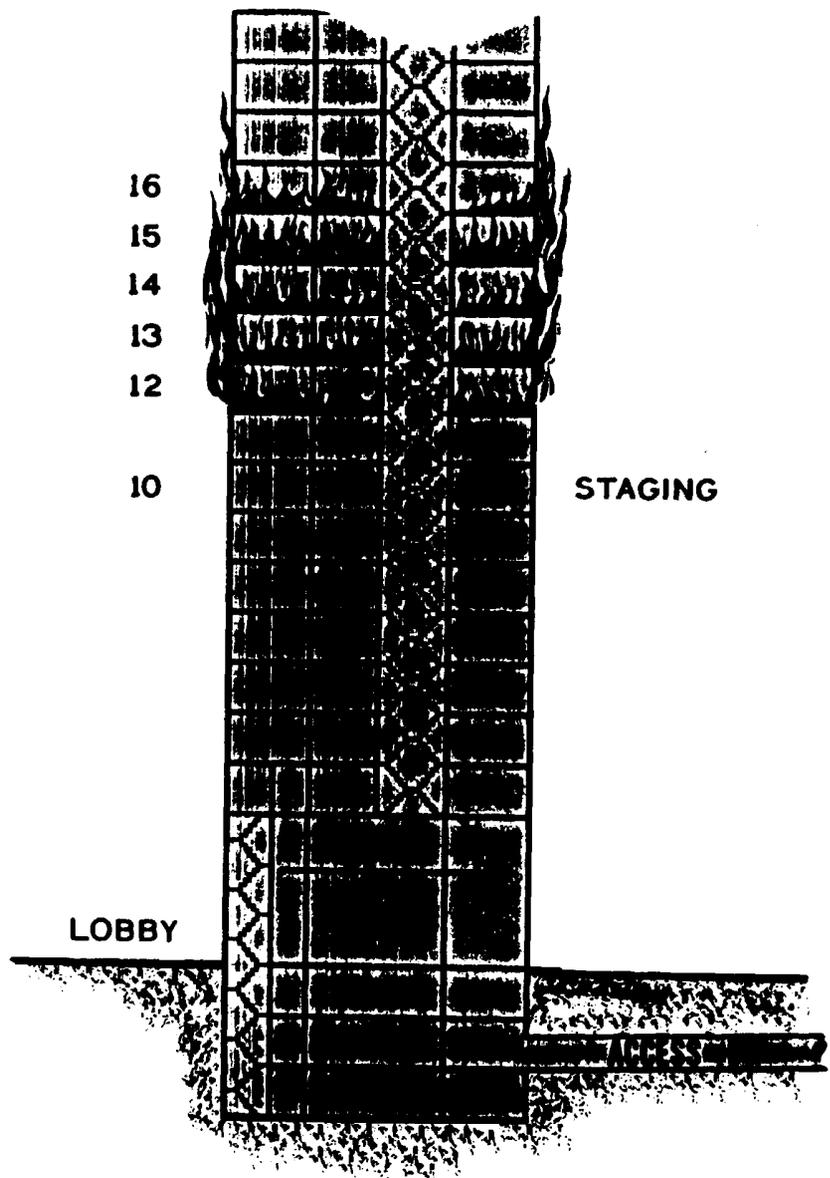
It soon became evident from the exterior and the interior that the fire was spreading upward. Companies successively launched attacks from all four stairways onto the 13th, 14th, 15th, and 16th floors, often encountering heavy fire from the point of entry and having to fight their way onto the floors with handlines. At times active suppression efforts were underway simultaneously on four levels as crews attempted to push the fire back from the central core to the perimeter of each floor. As more doors were opened, conditions in the stairways deteriorated with heat and smoke going up and water cascading down. (Appendix D shows a vertical cross-section of the building and the fire floors.)

16  
15  
14  
13  
12  
10

STAGING

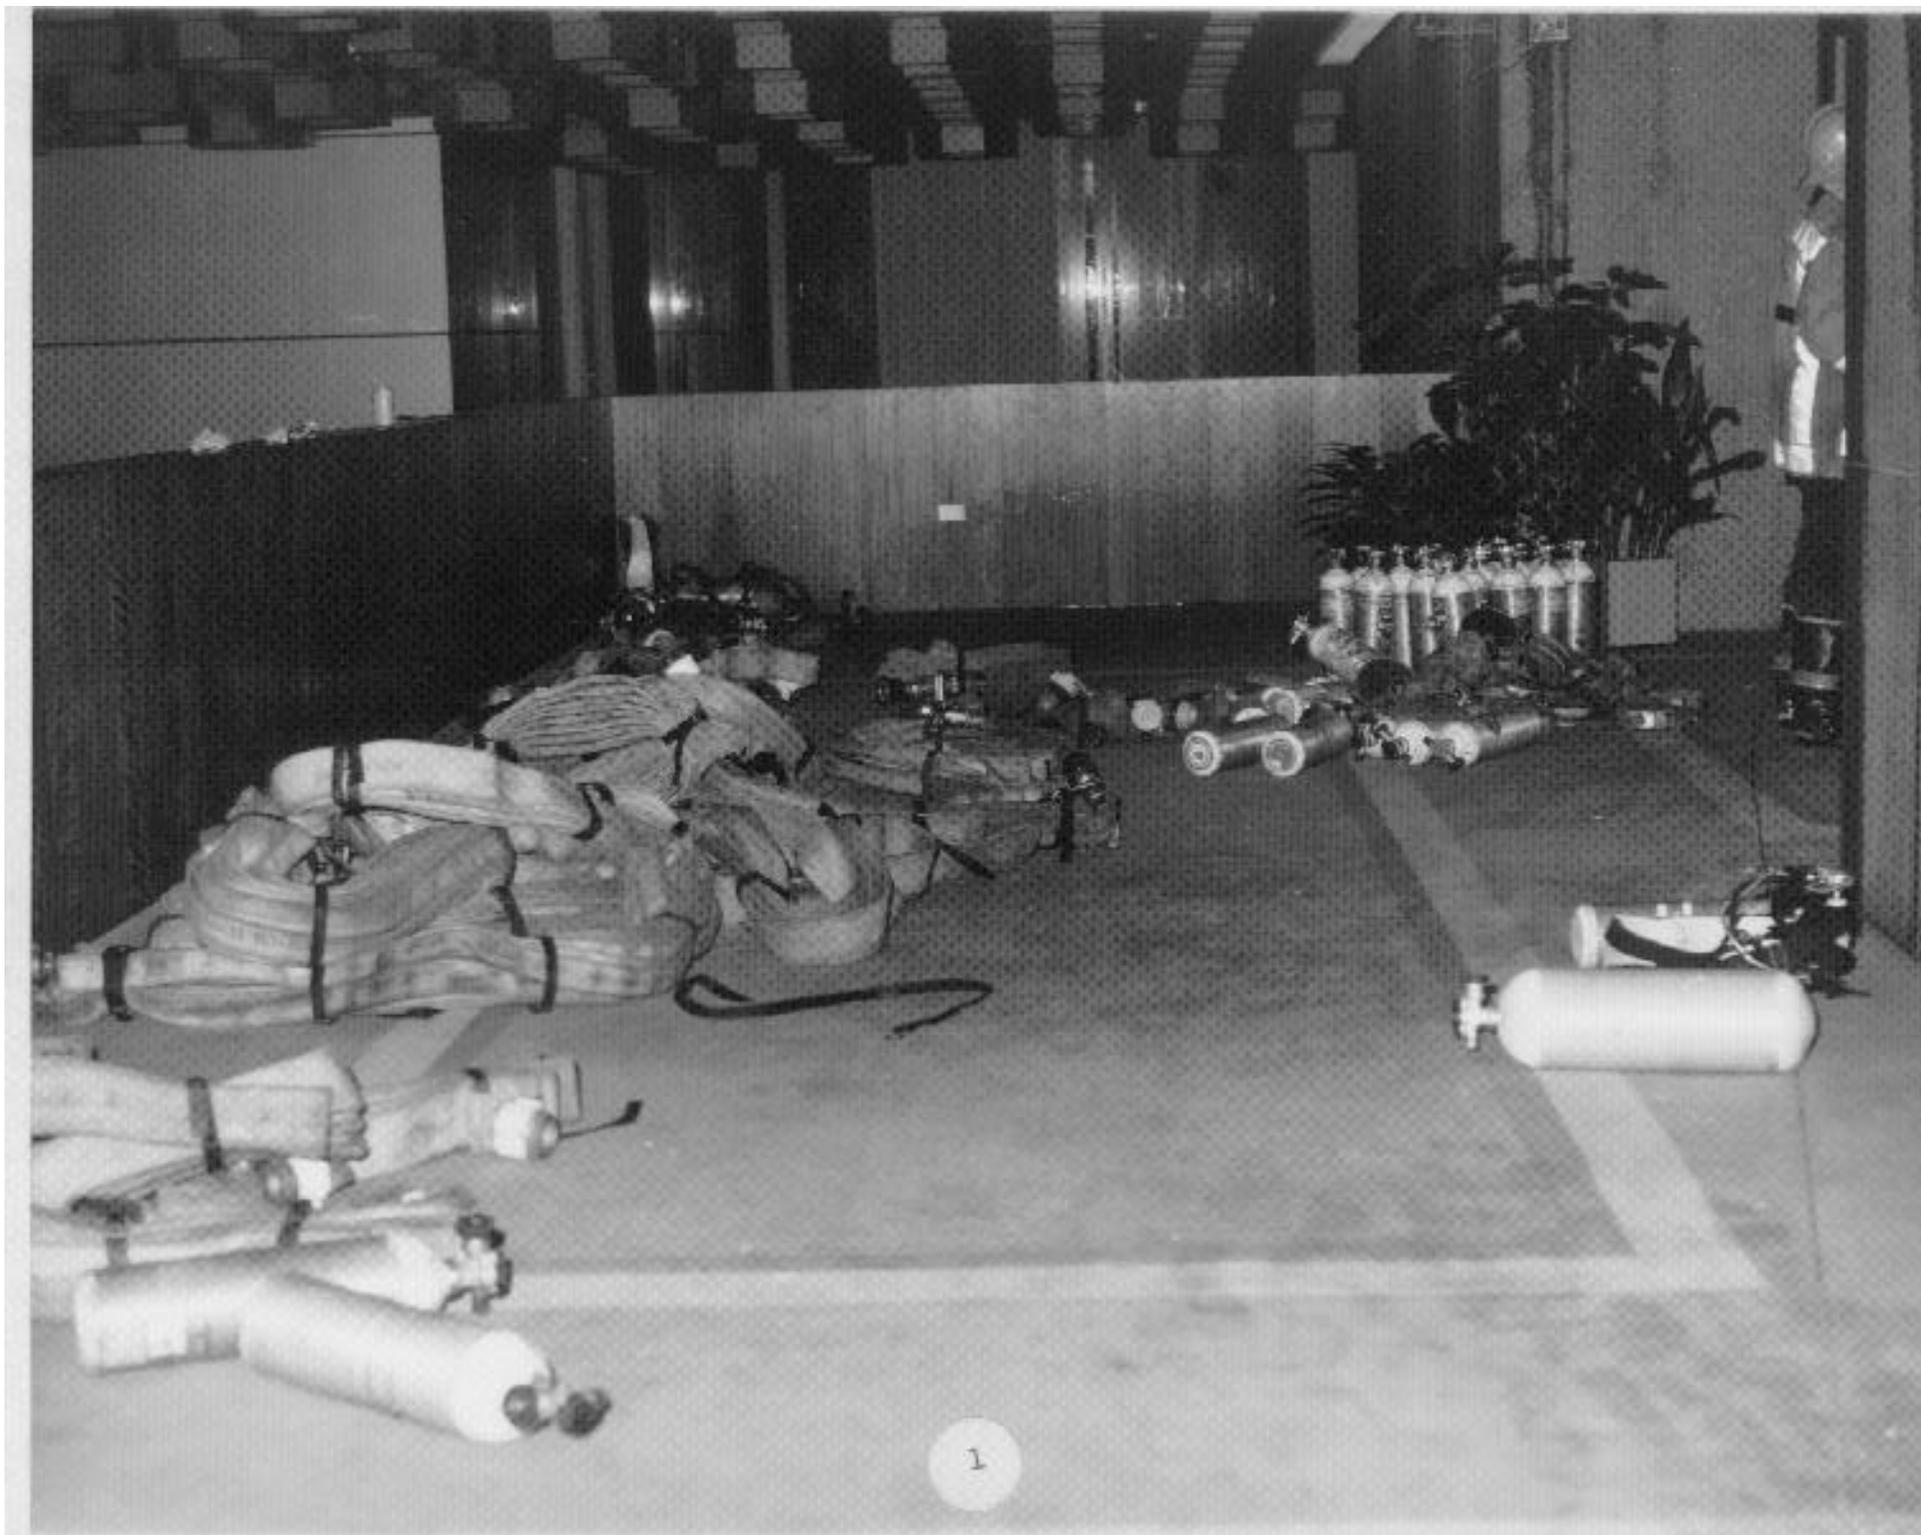
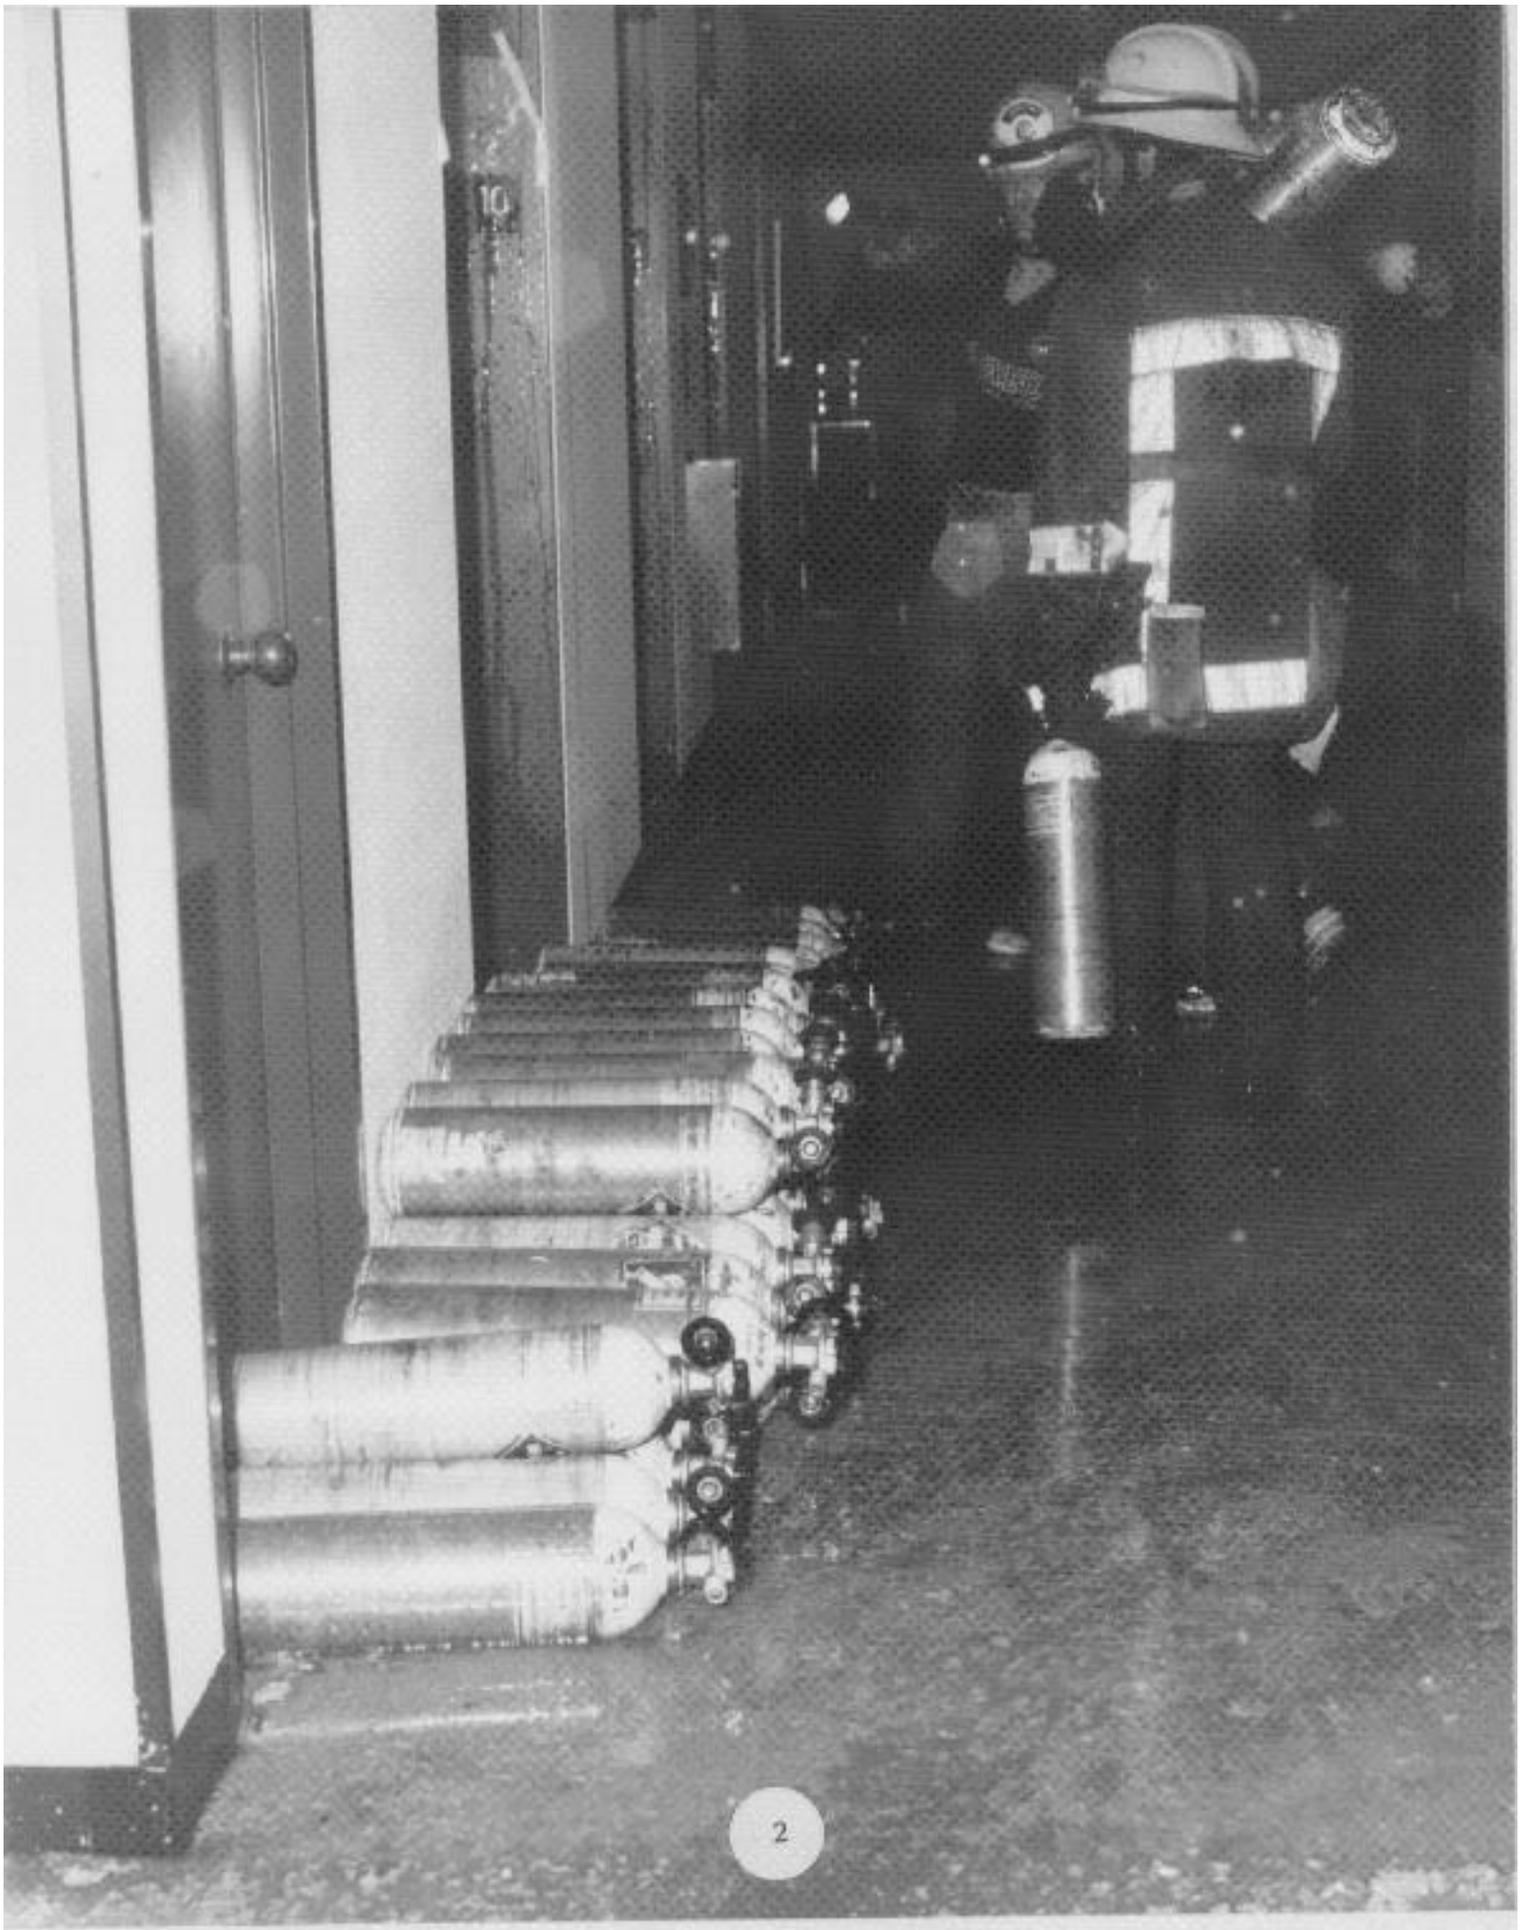
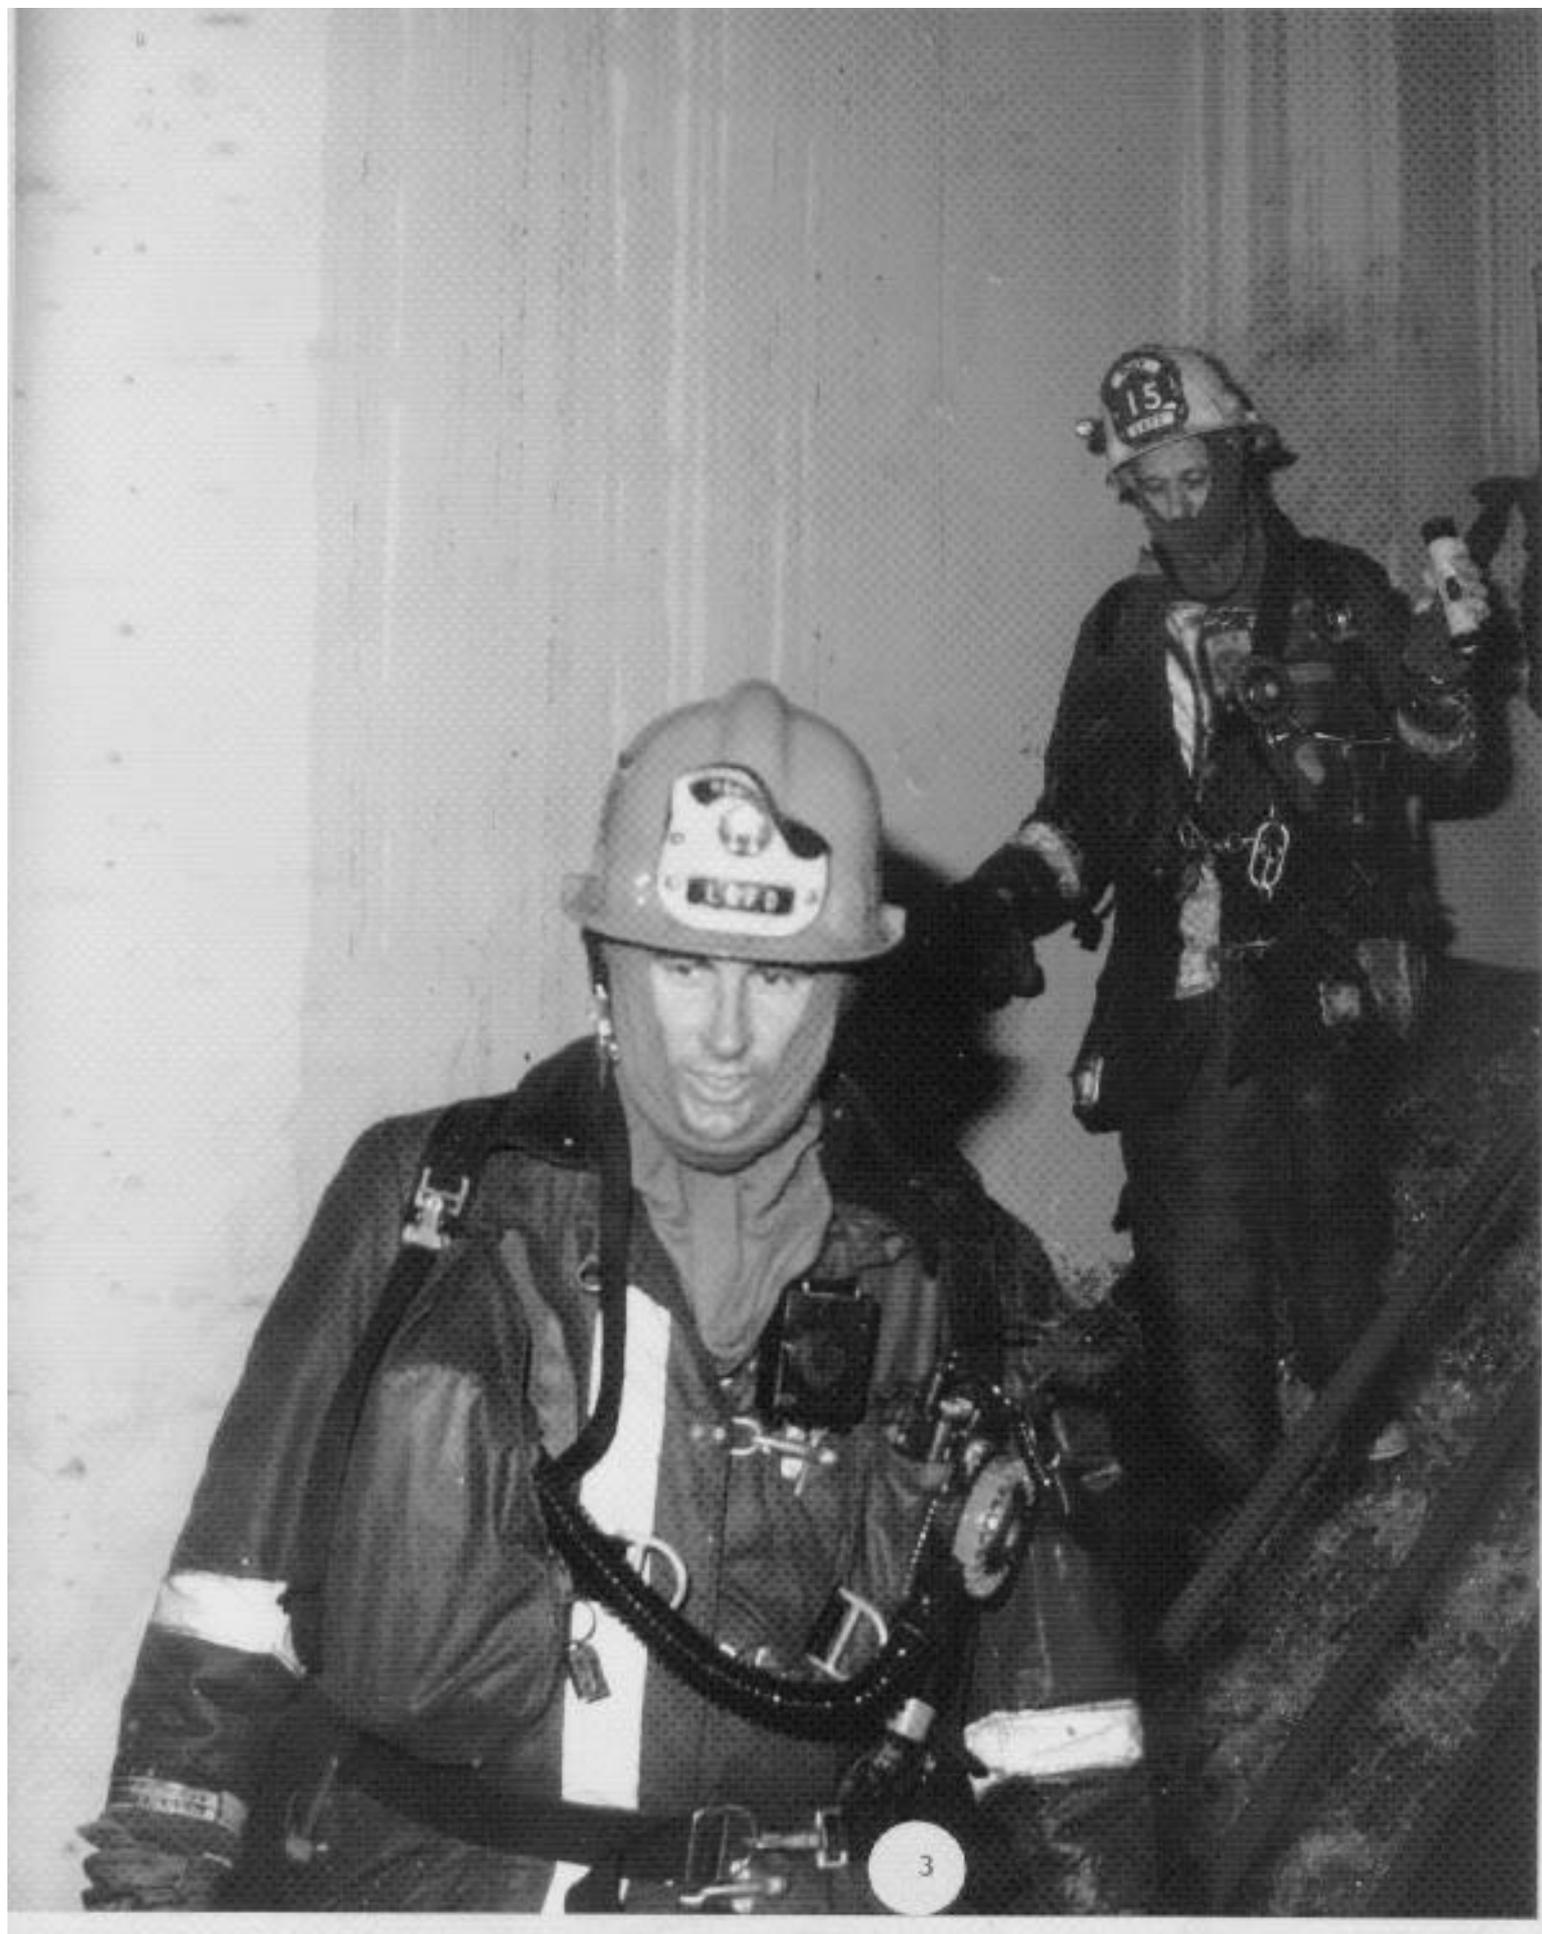
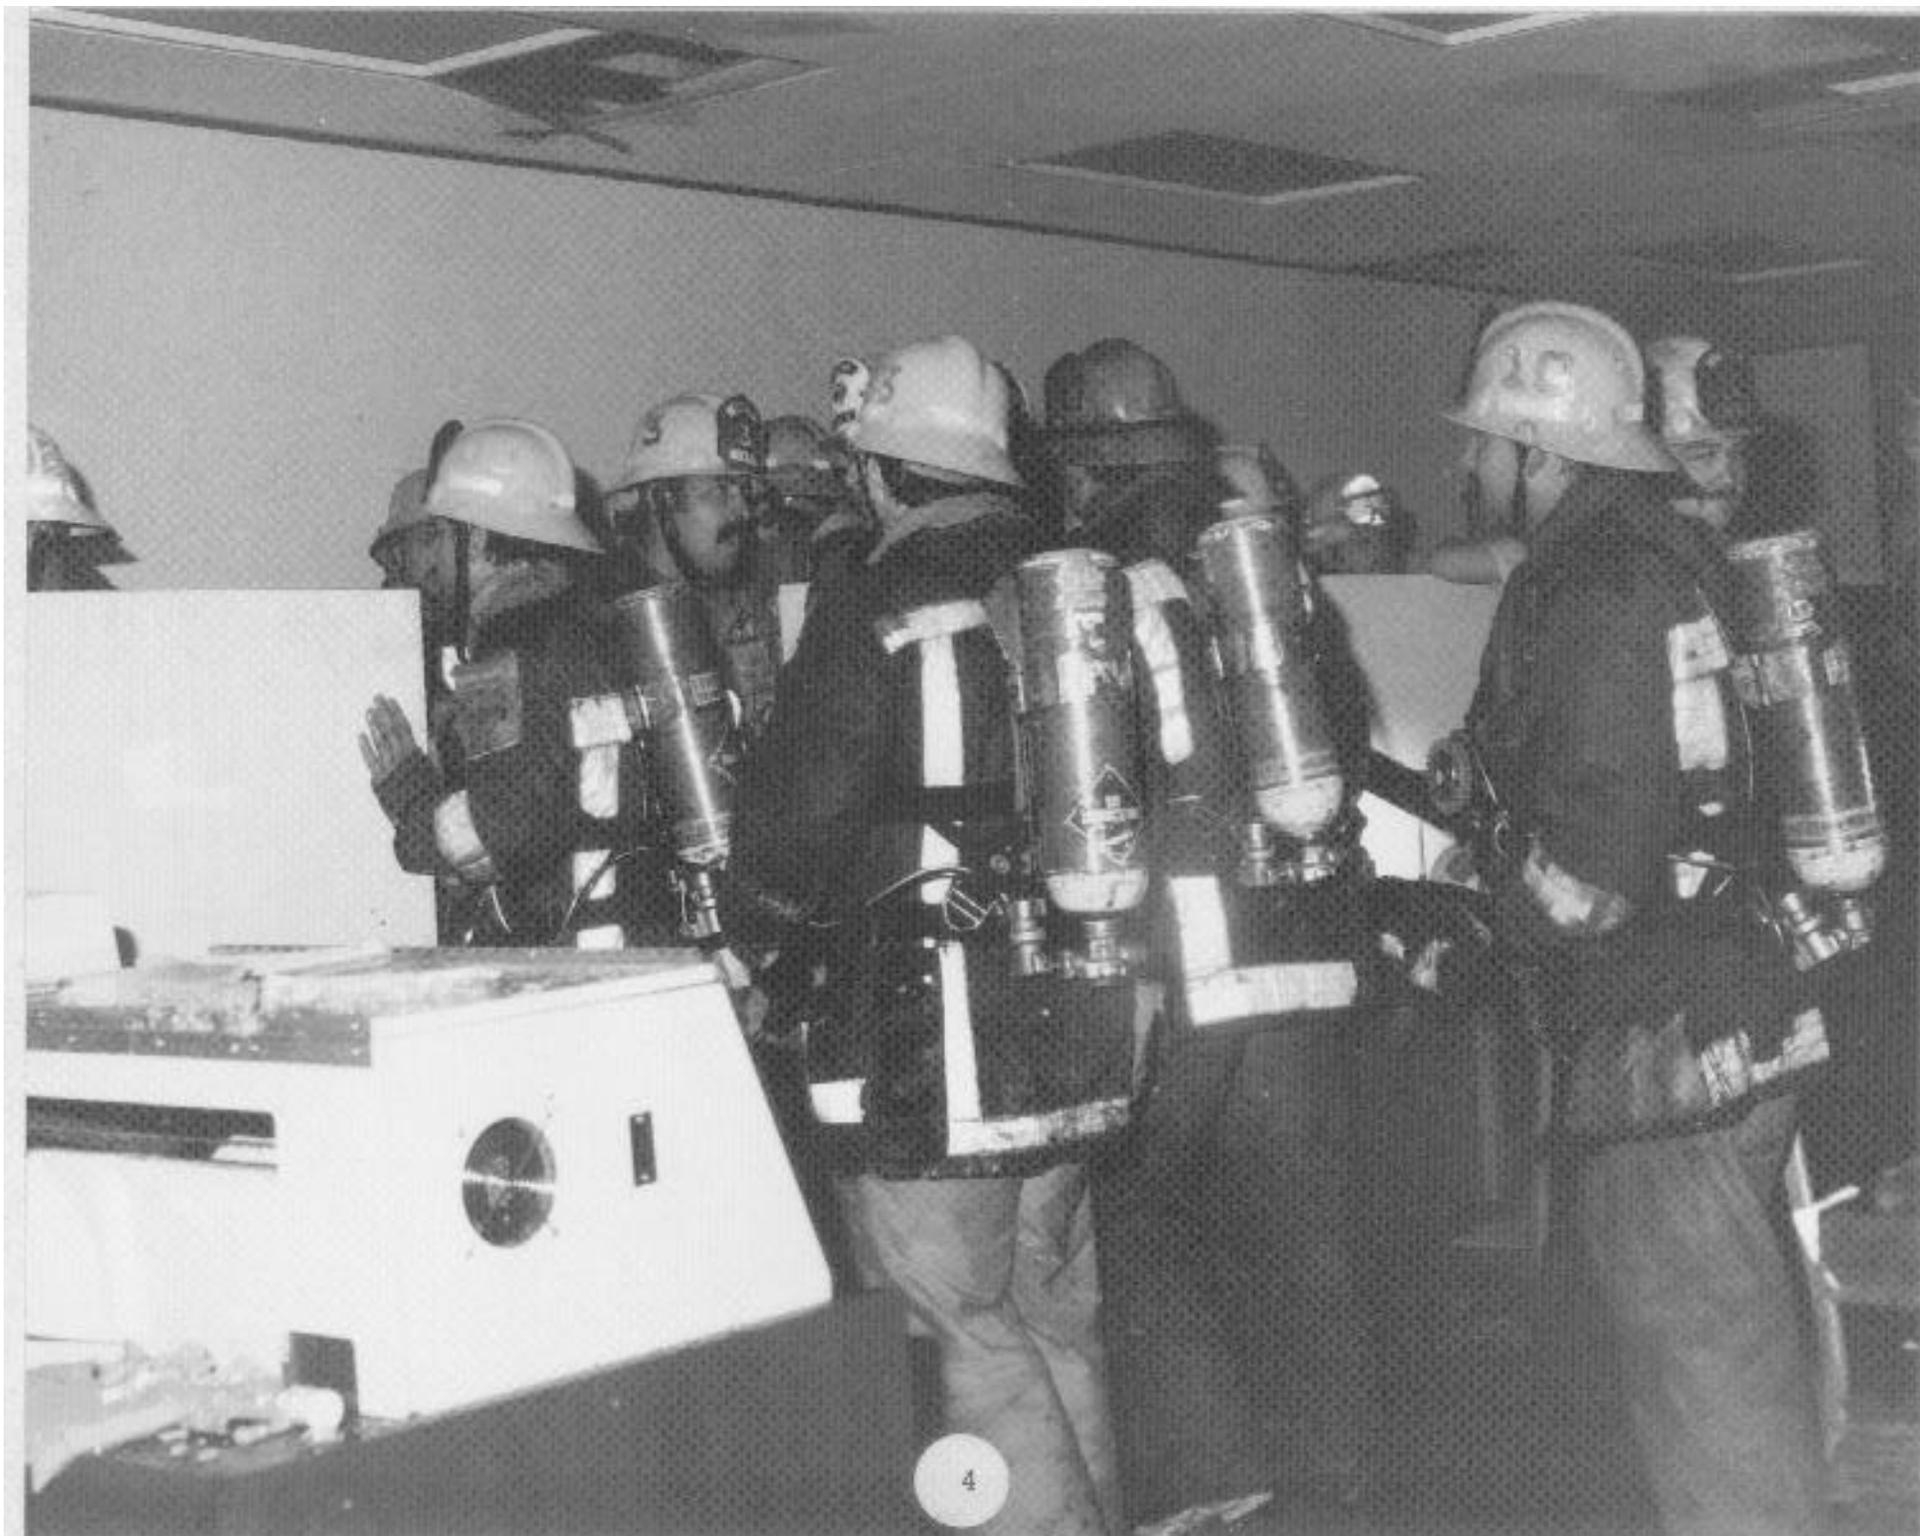
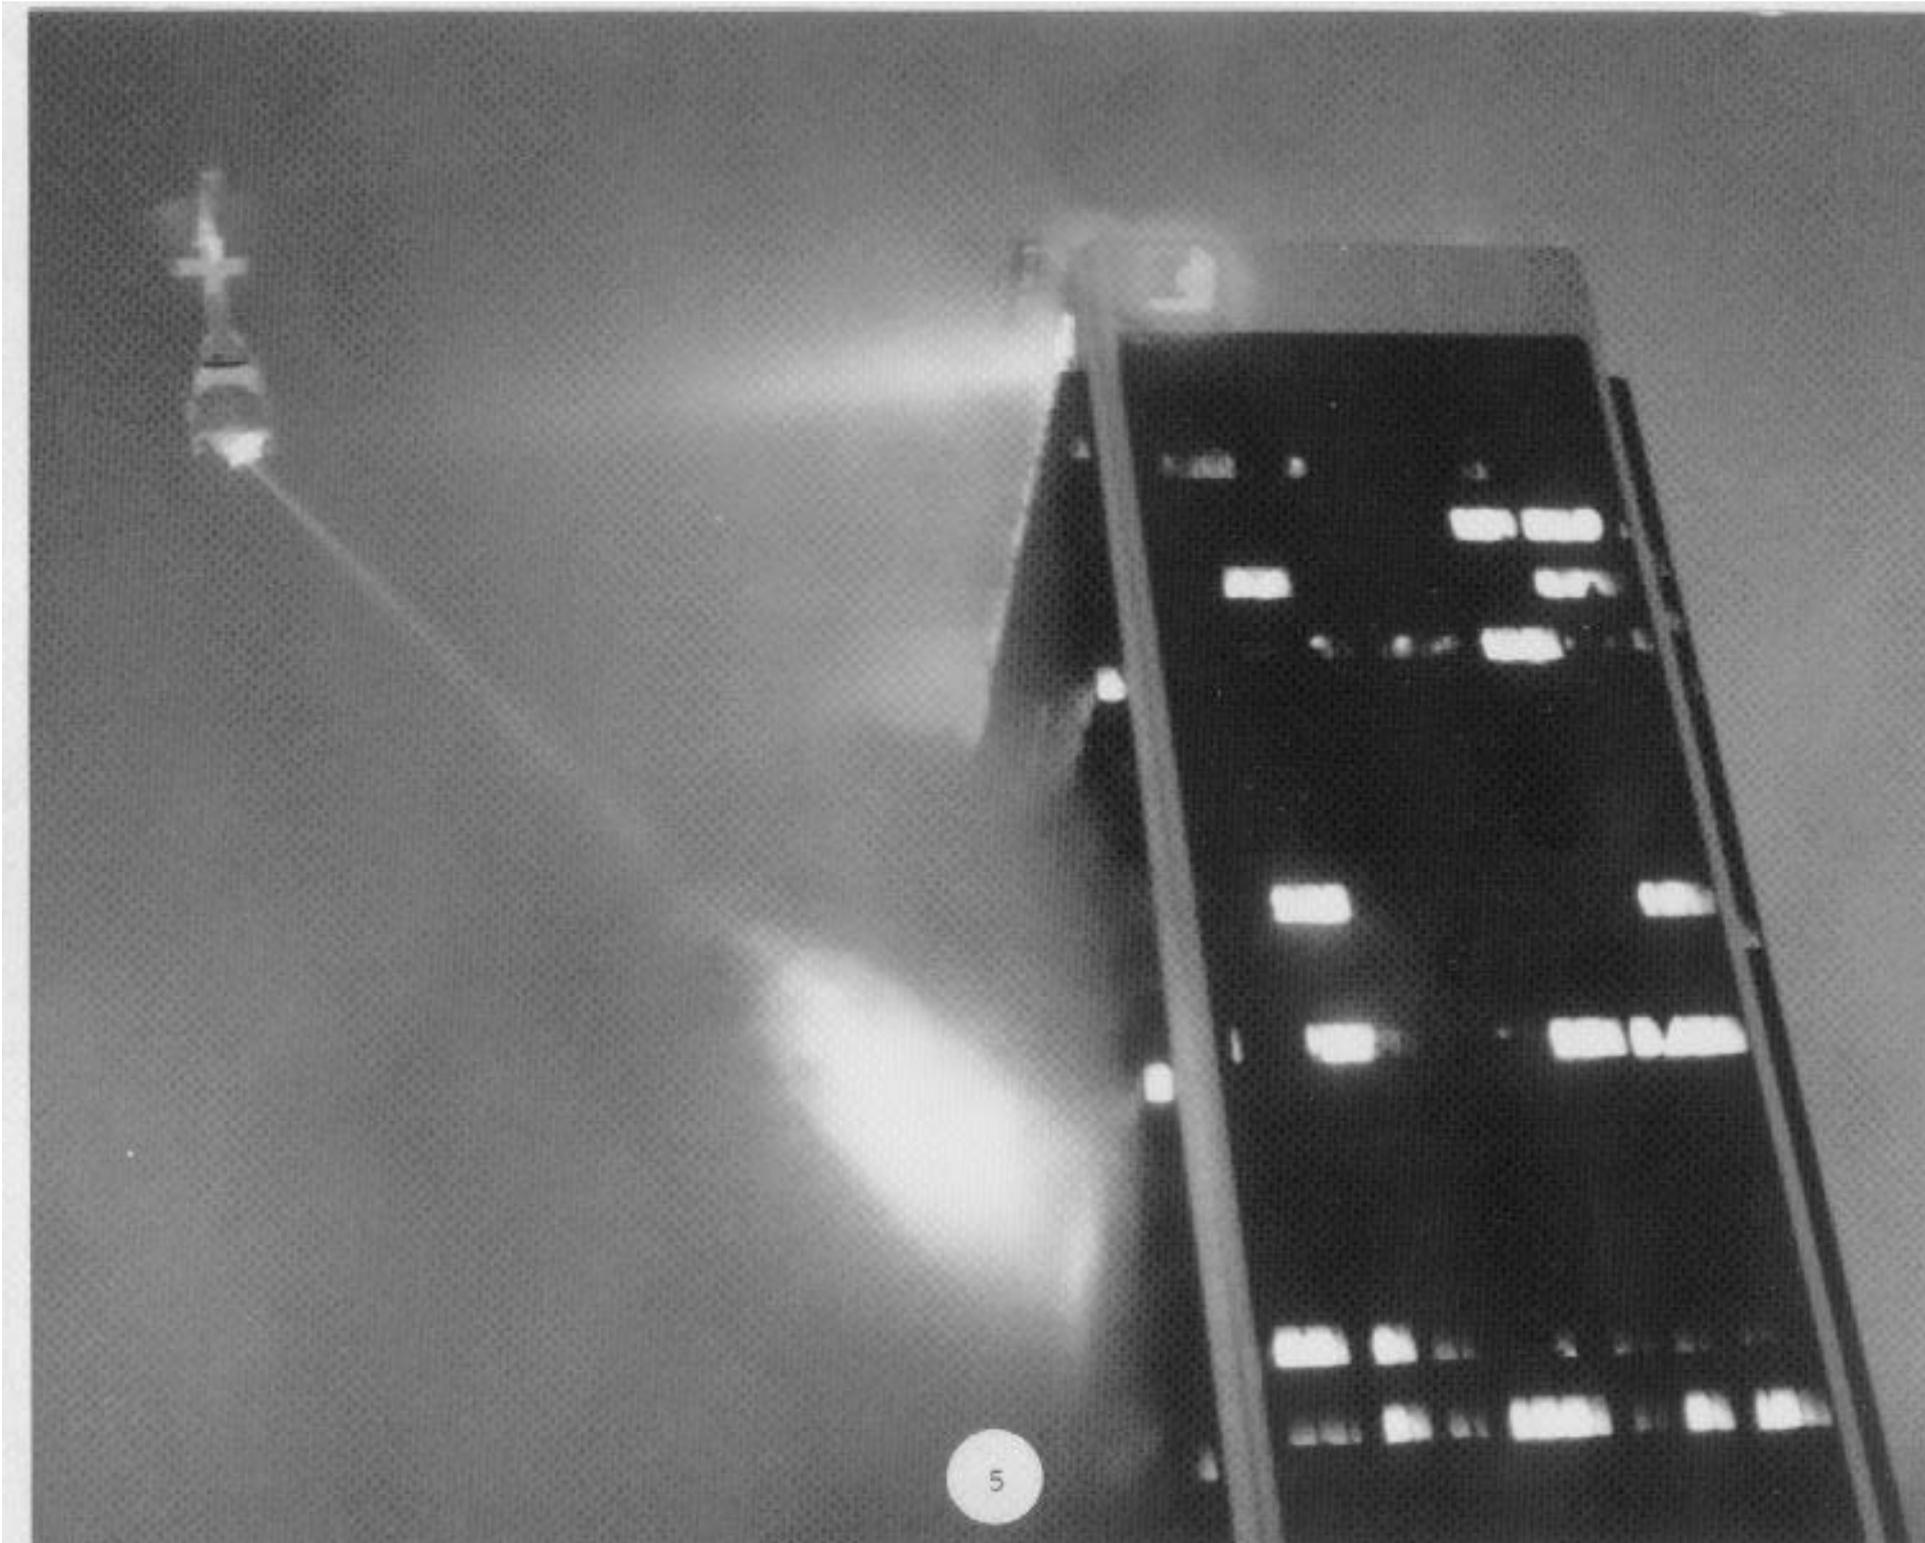
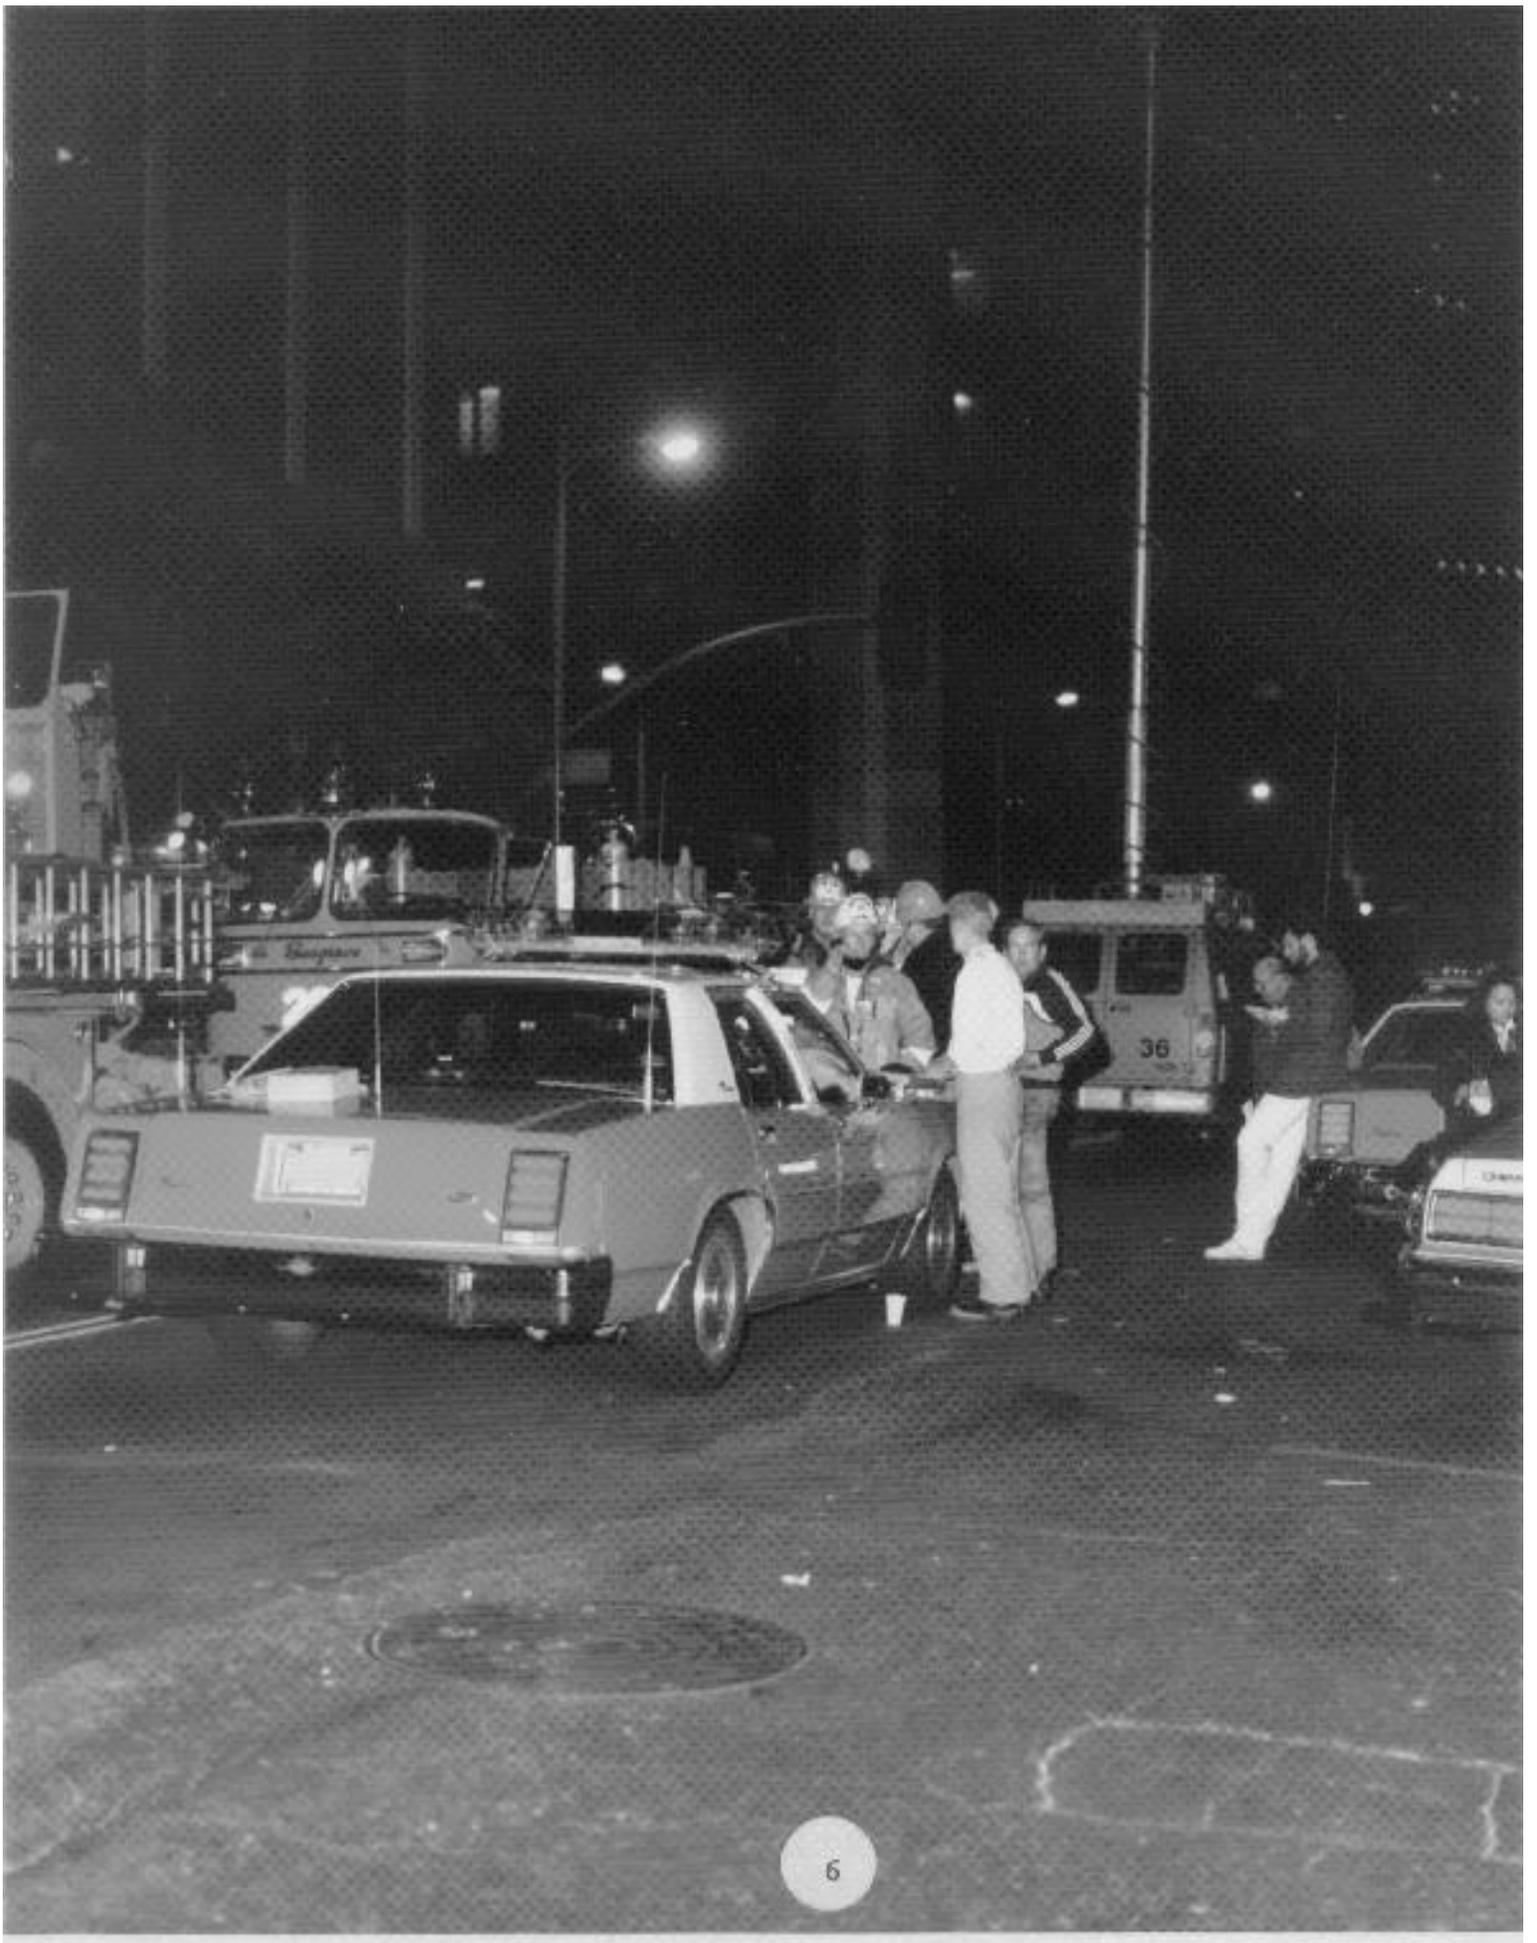
1. Lobby control equipment pool.
2. Empty air bottles in staging.
3. Task Force 15 Returning to staging  
Note hoods and water in stairwell.
4. Tenth floor staging area.
5. Helicopter searching 50th floor for  
trapped civilians.
6. Wilshire Incident Command.
7. Evidence of smoke in elevator shaft  
at 42nd floor.
8. Stairwell 6 at 22nd floor showing smoke leakage.
9. Twisted aluminum framework northeast corner of  
building.
10. Void between floor and exterior glass.
11. Plate glass windows on the 16th floor.
