The Dieweg Fire

Presentation:
Karel Lambert - Brussels Fire Department

Version 0.2
14/03/2011

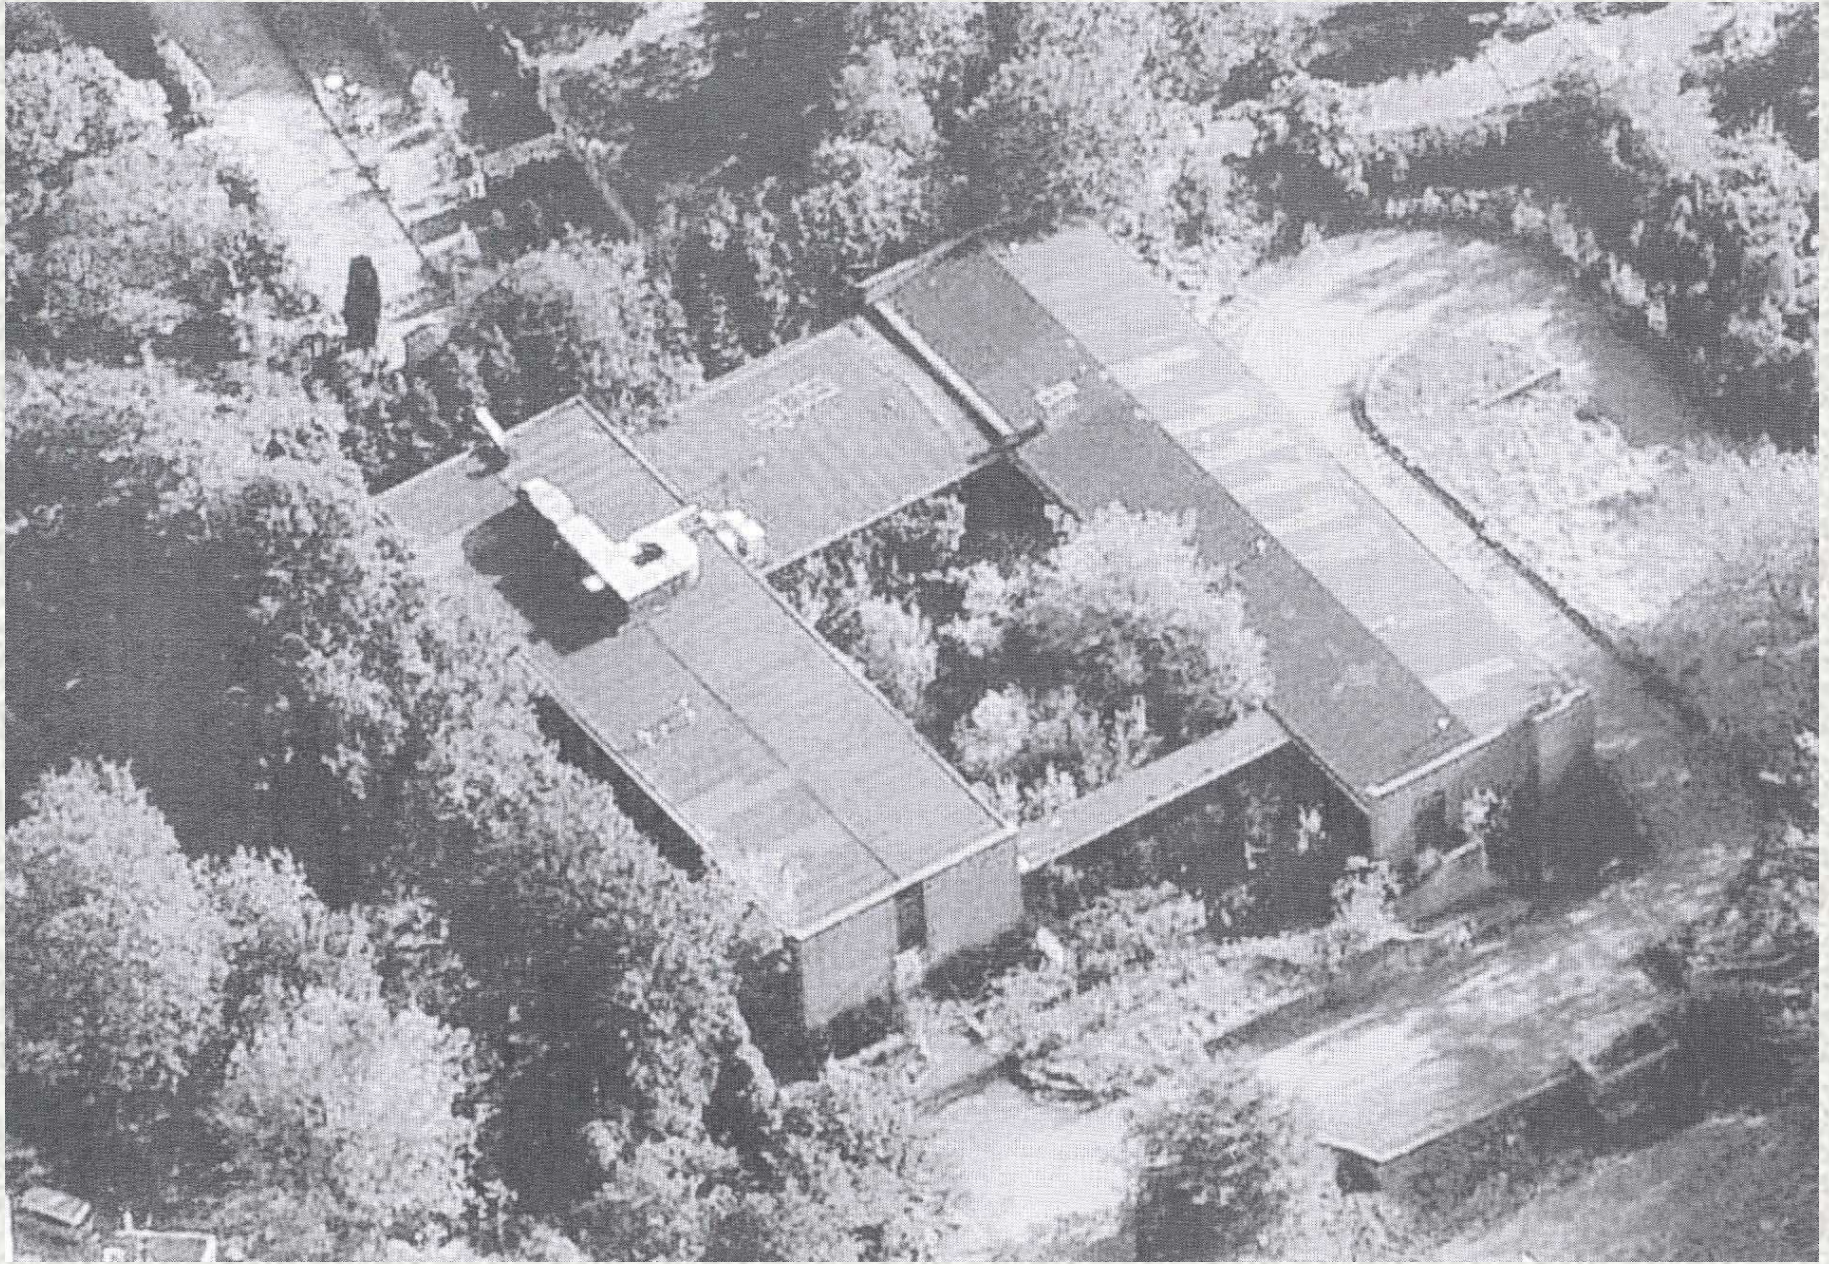
Problems caused by location

- Distance to neighboring streets
 - ➔ Caused difficult water supply
- Big difference in height between Dieweg and St-Job Street.
 - ➔ Difficulties to do a 360° reconnaissance
 - ➔ No global vision possible

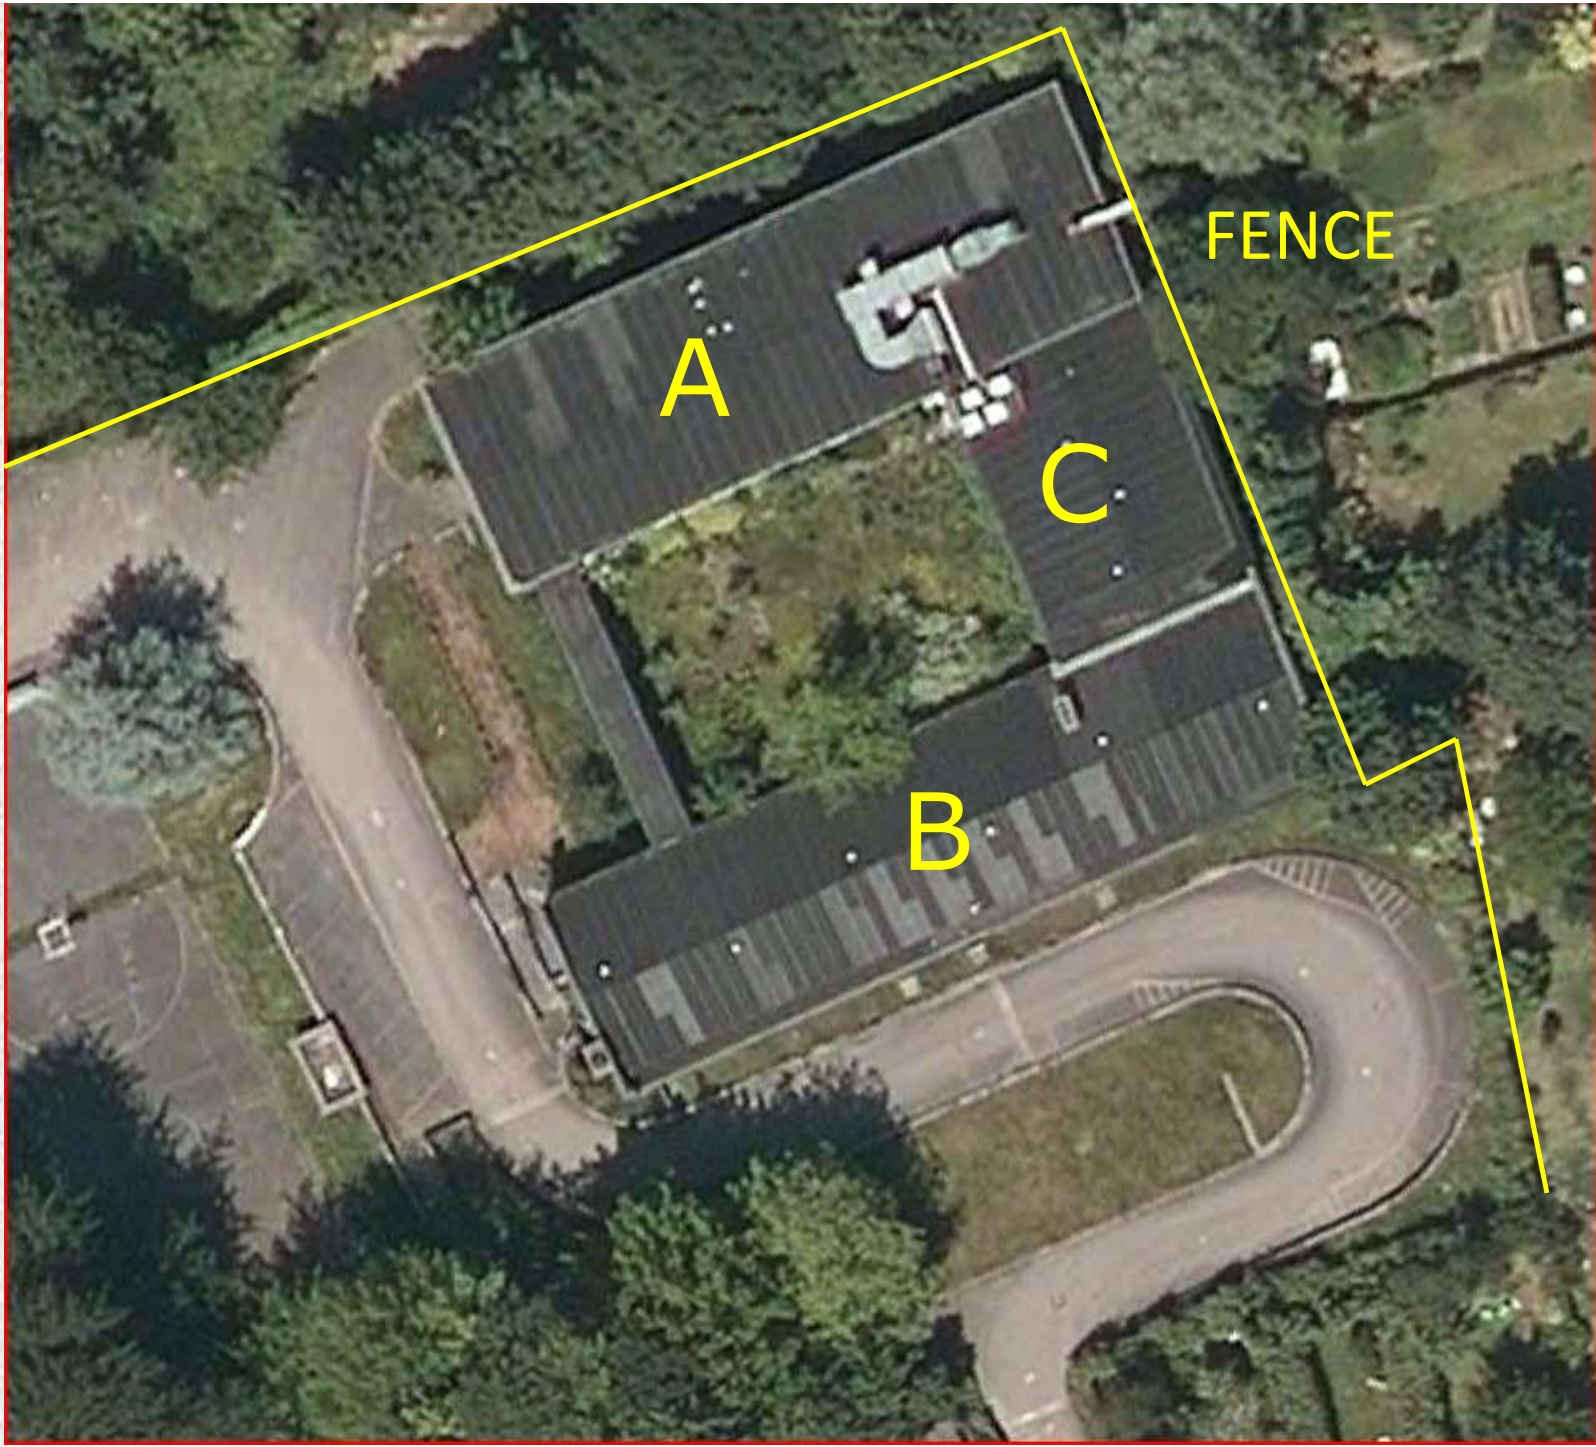
Reconnaissance

- 360 ° Reconnaissance was not possible due to fire conditions and the fence between the site and the neighbouring sites.
- Reconnaissance was difficult because of the difference in height
- There was no global view because of smoke.

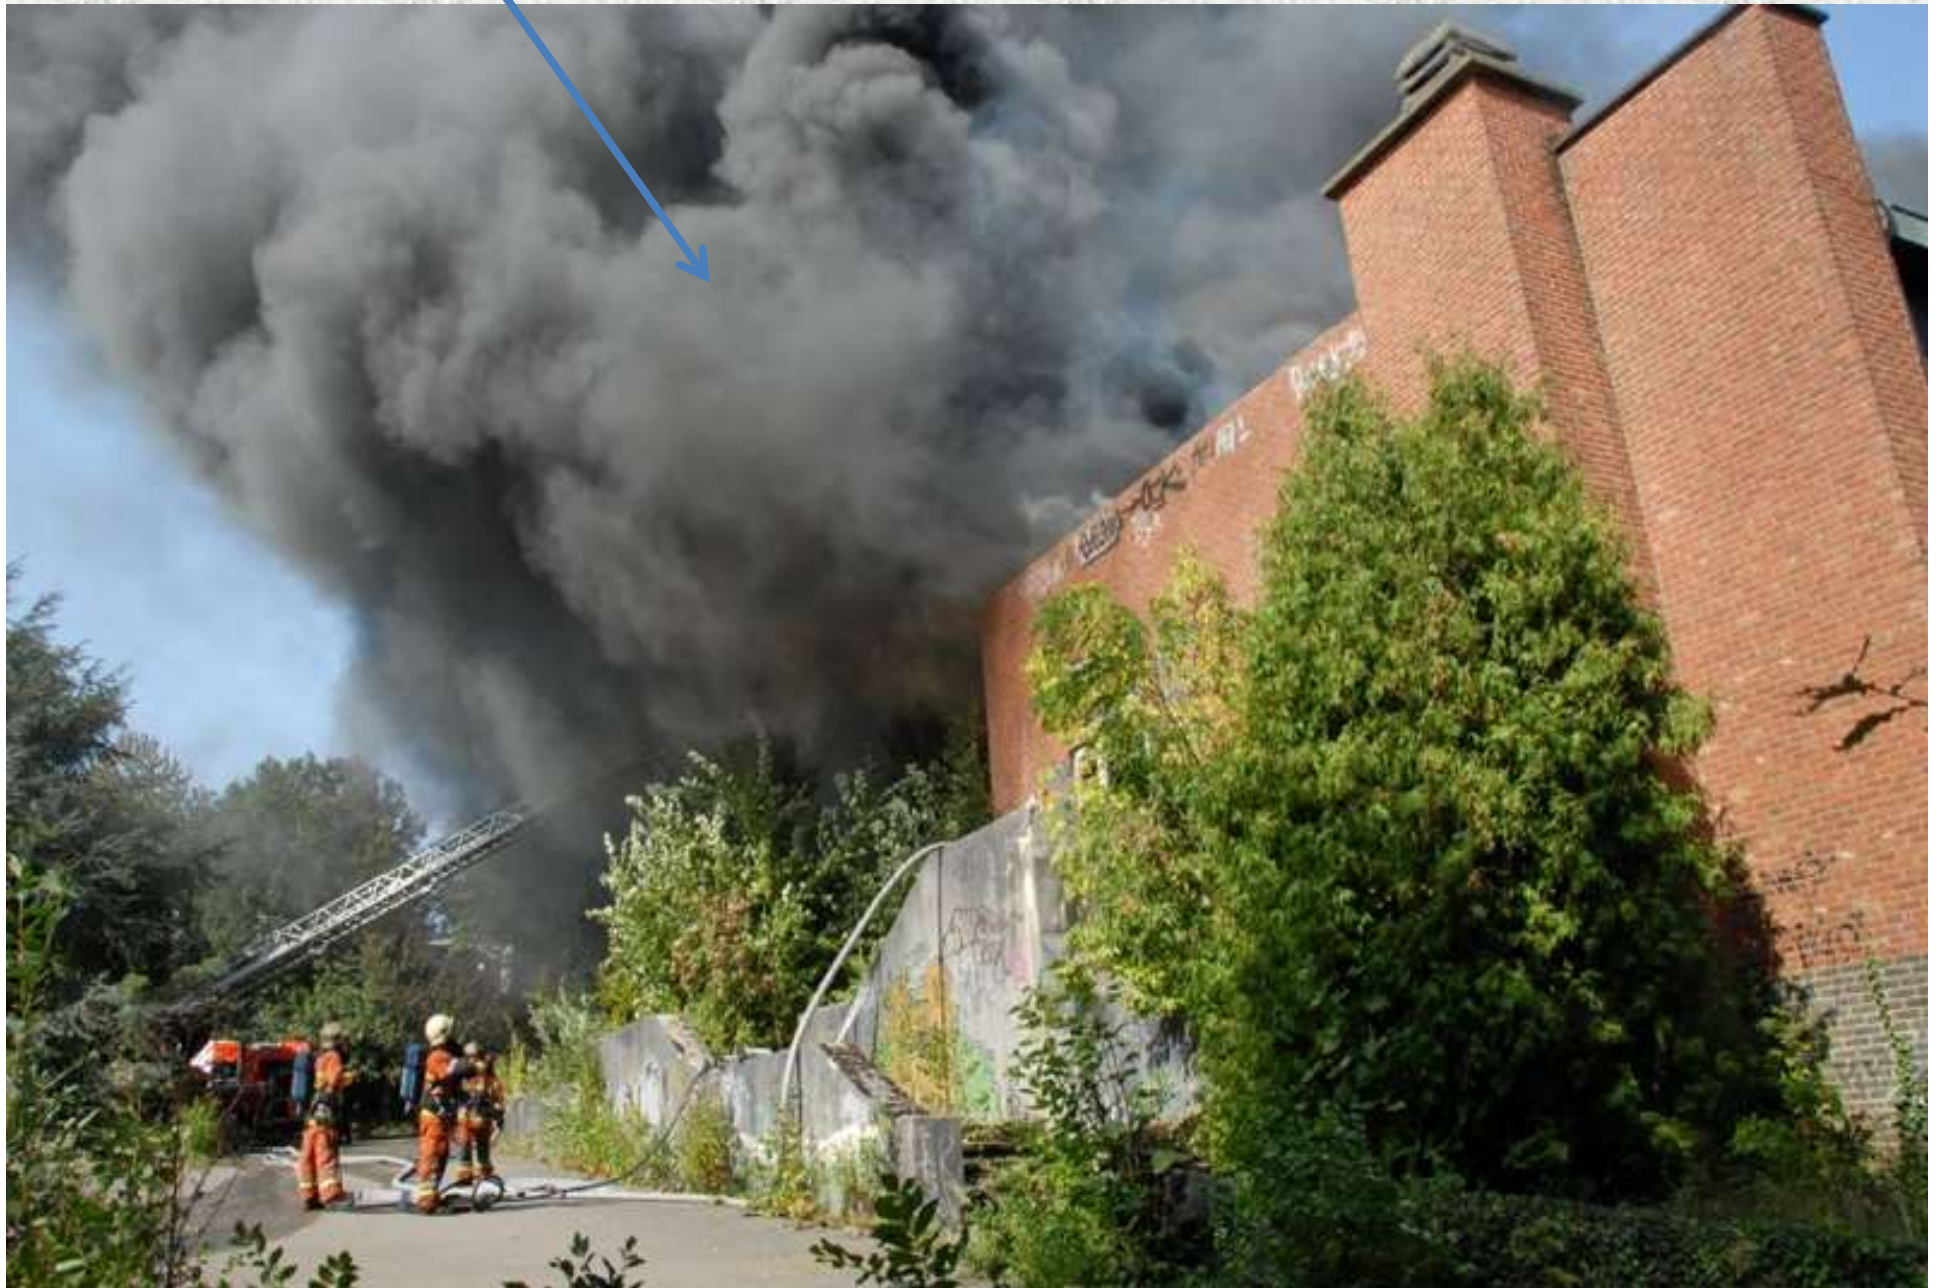
Heavy smoke blocks
view on building C

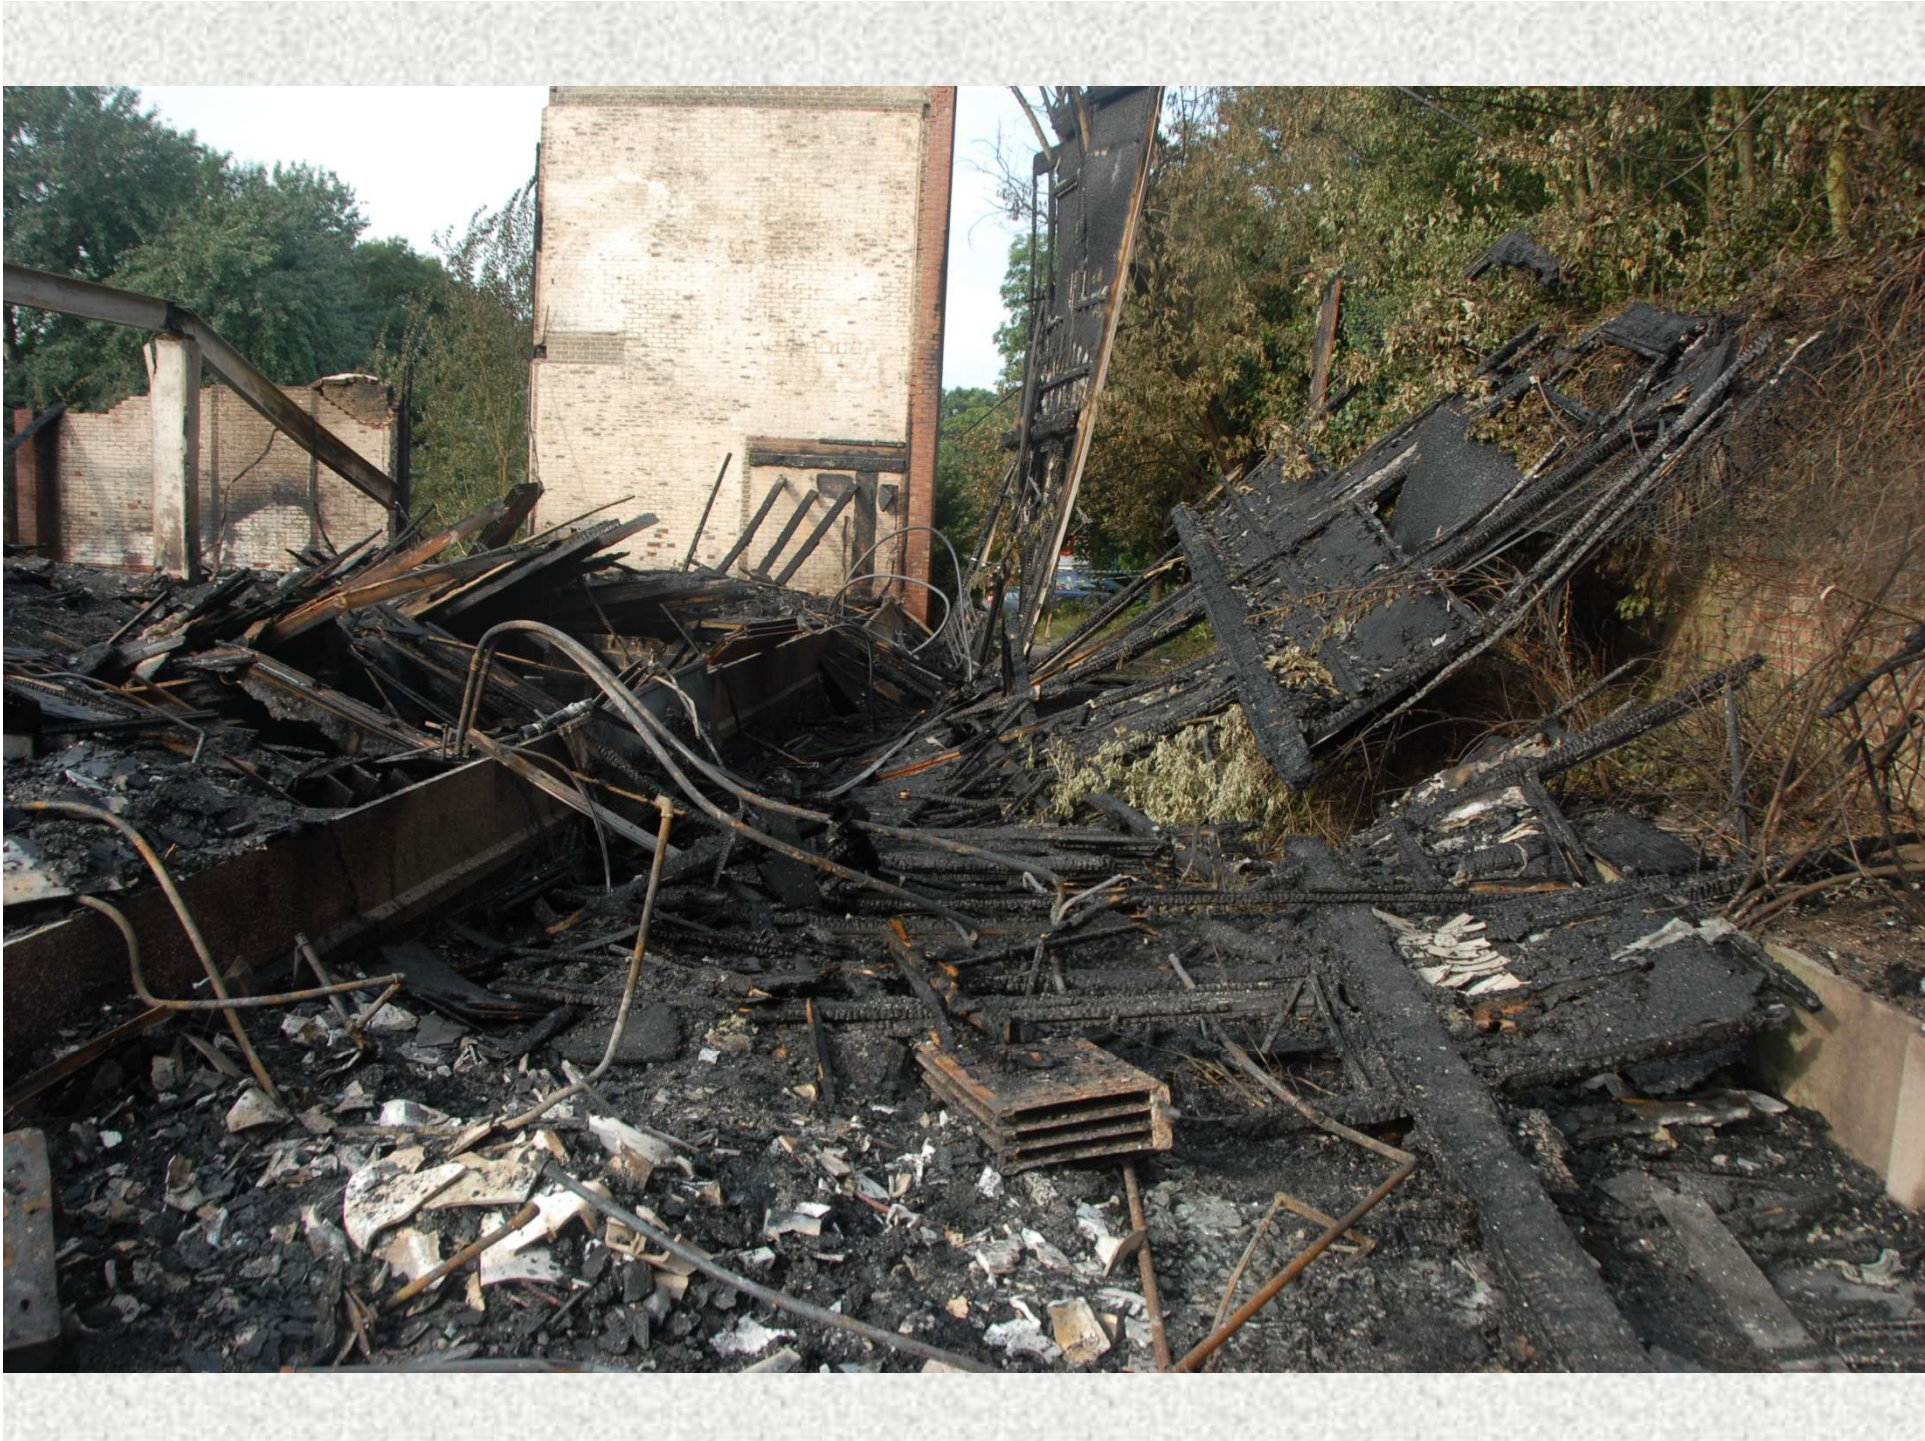
Building B

- 45 metres (148 ft) long / 14 metres (46 ft) wide
- 2 floors (2nd floor = 1st floor building A)
- 1st Floor is constructed with concrete and steel girders and wooden lightweight walls
- The long walls of the 2nd floor are lightweight but cover only one floor.
- The two facades are brick walls

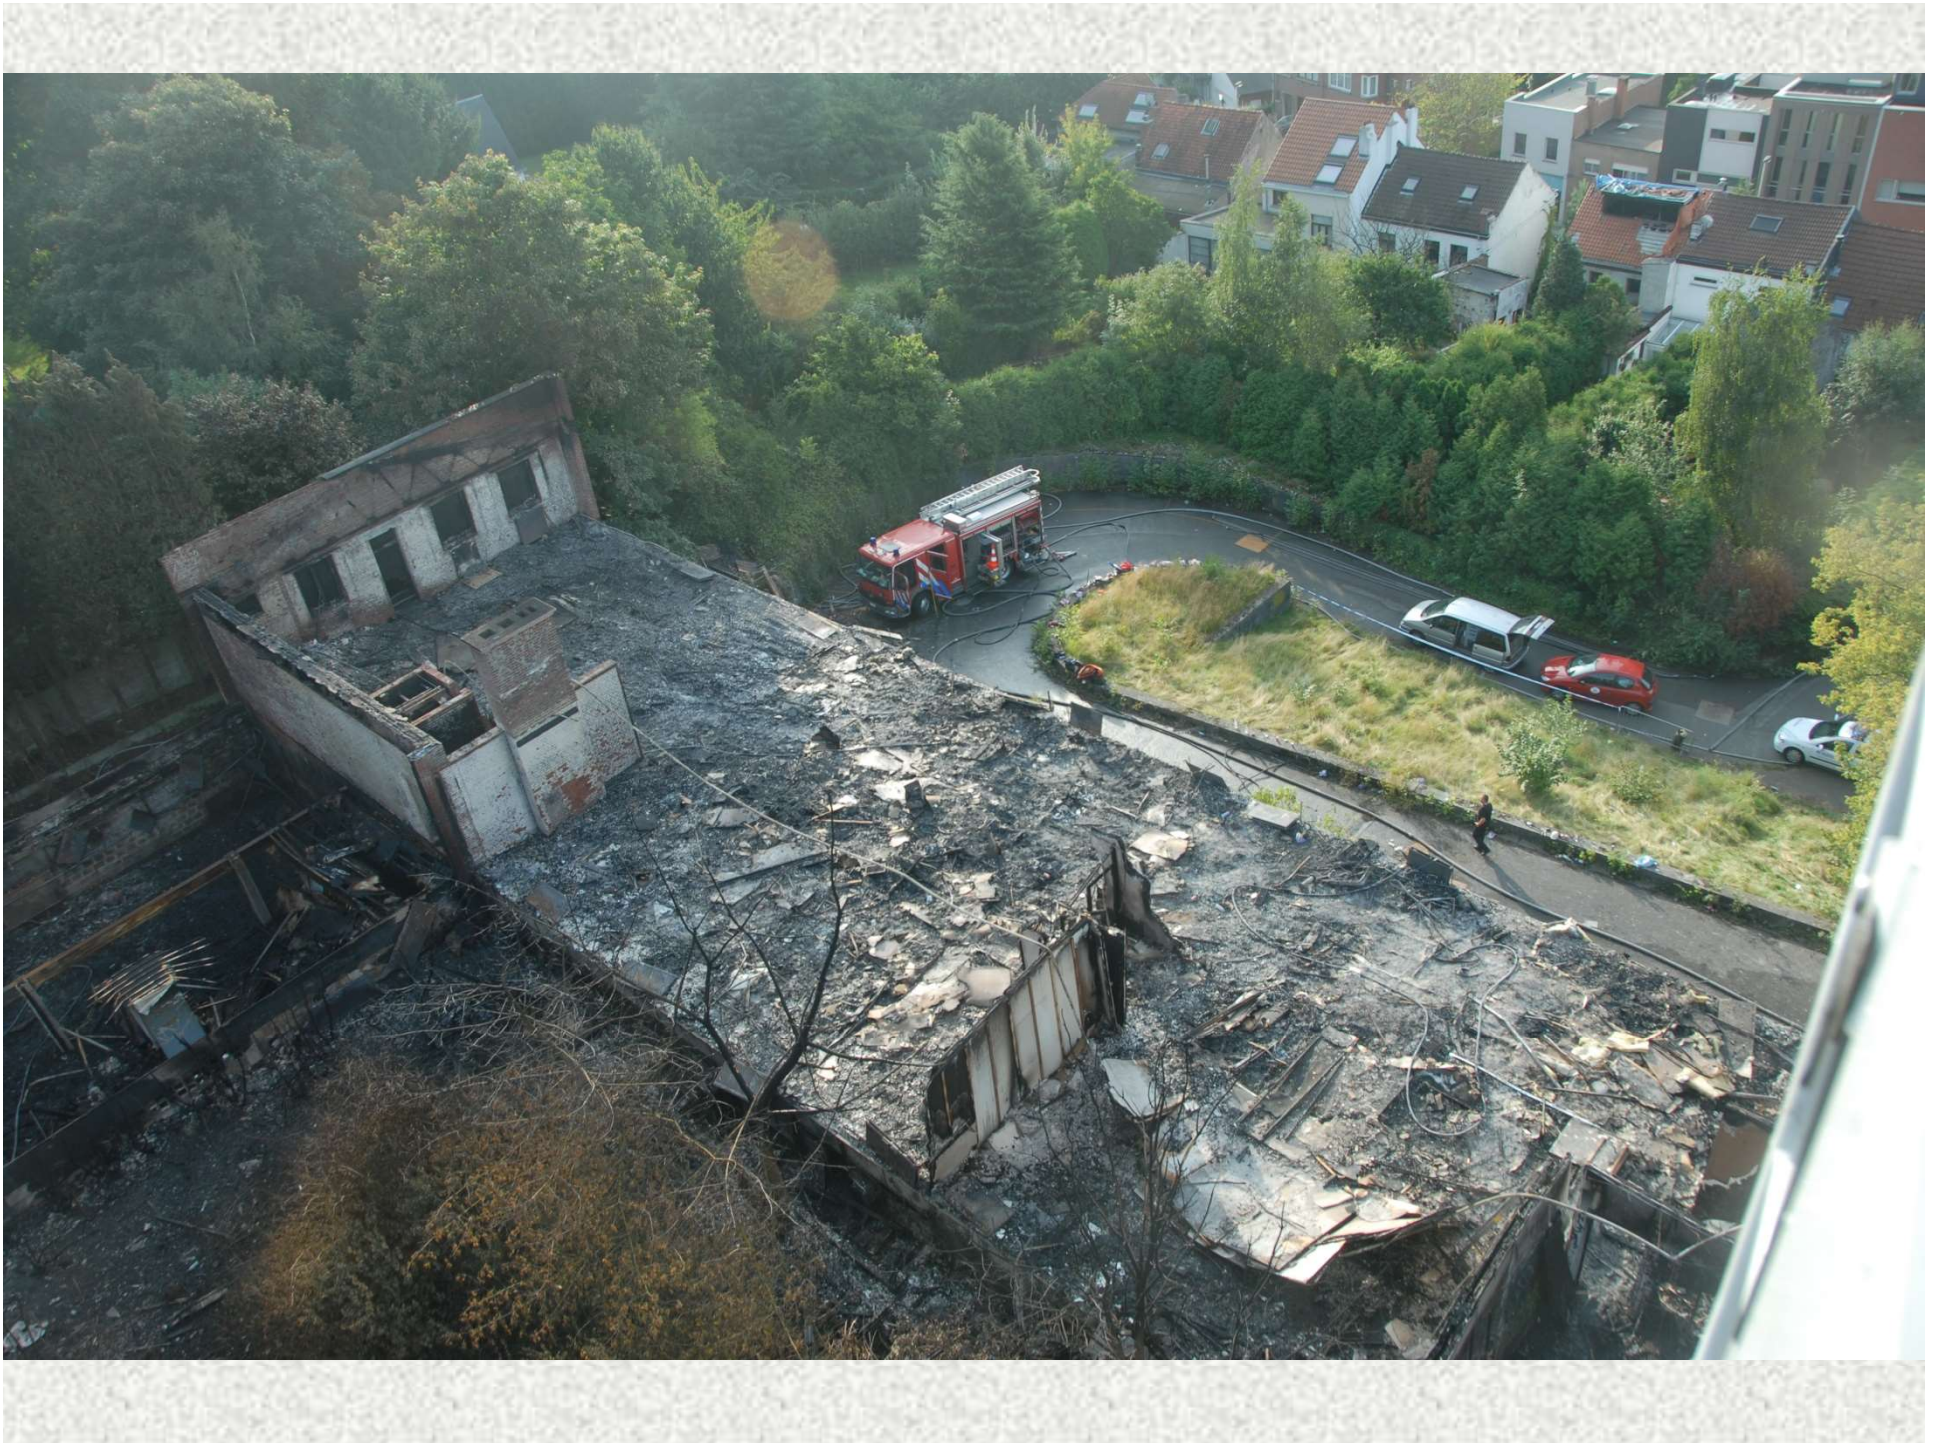
Building C

- 16 metres (52 ft) long & 43 ft wide
- Basement + 1 floor
- Basement is constructed with concrete and steel girders
- 1st floor is constructed with lightweight materials
- The roof has a slight inclination
- There was a void space under the roof

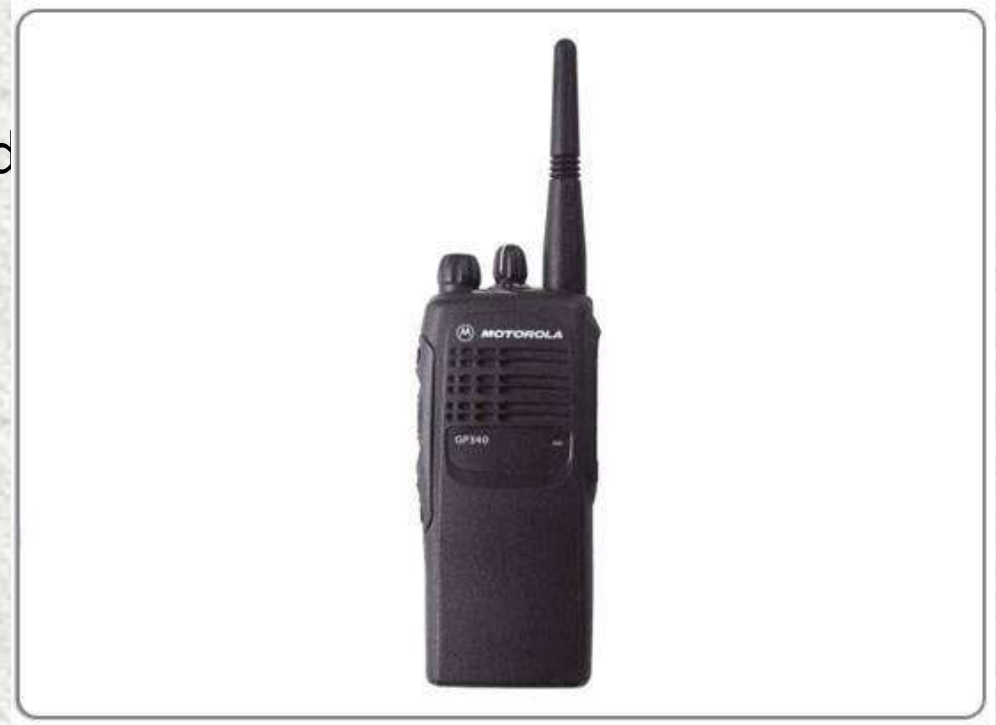
- The man in the basket of the second ladder explains afterwards that he observed flames running along the roof of building B.
- He sent a warning via his radio but the message wasn't heard by anyone.
- At that moment he saw the BC in training enter the building.

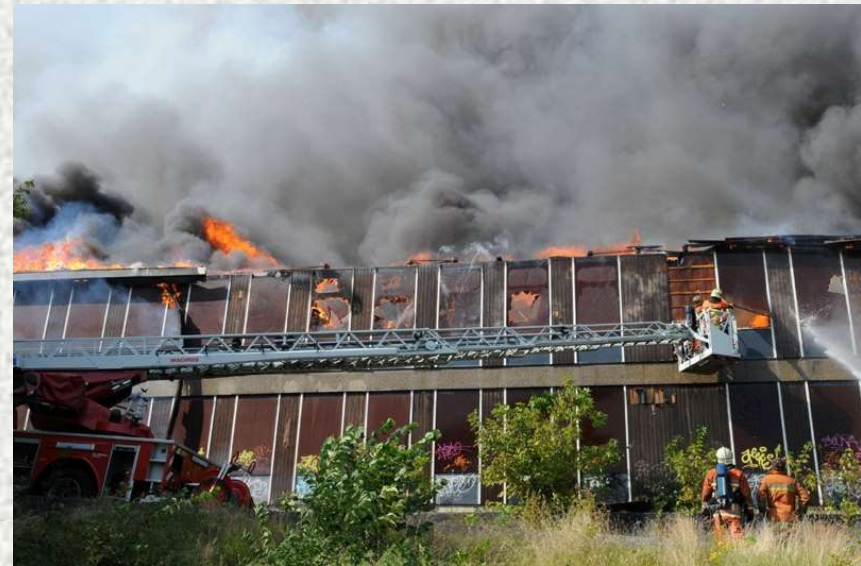
- The second ladder is deployed to open the windows on the second floor.
- Firefighters on the outside see the plates moving as one of the colleagues is banging from the inside
- The ladder is too short to the building to open the panel where the missing firefighters are located.

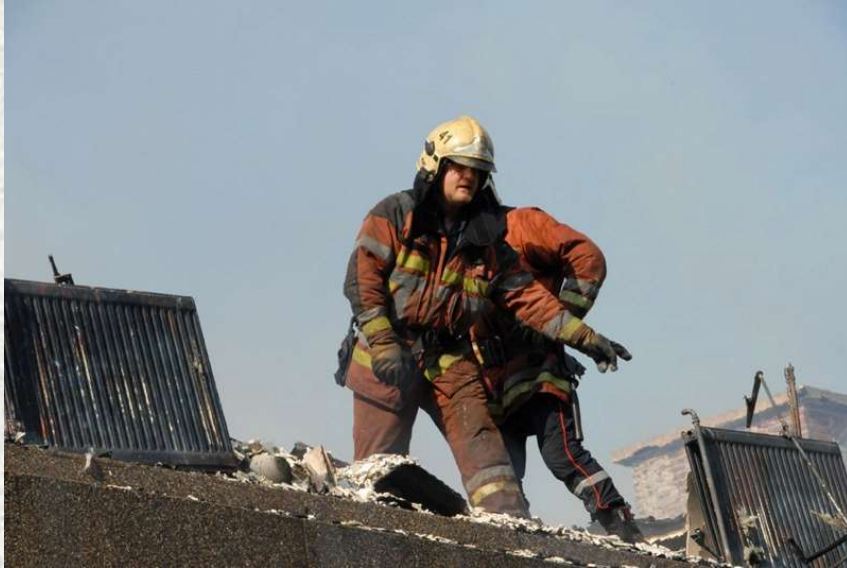
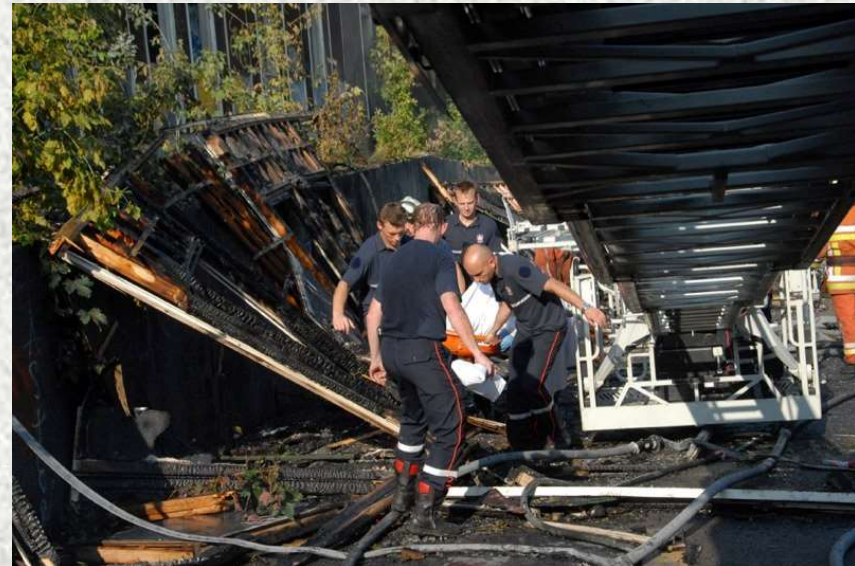
- Two firefighters were killed in this tragic incident.
- 7 others got wounded

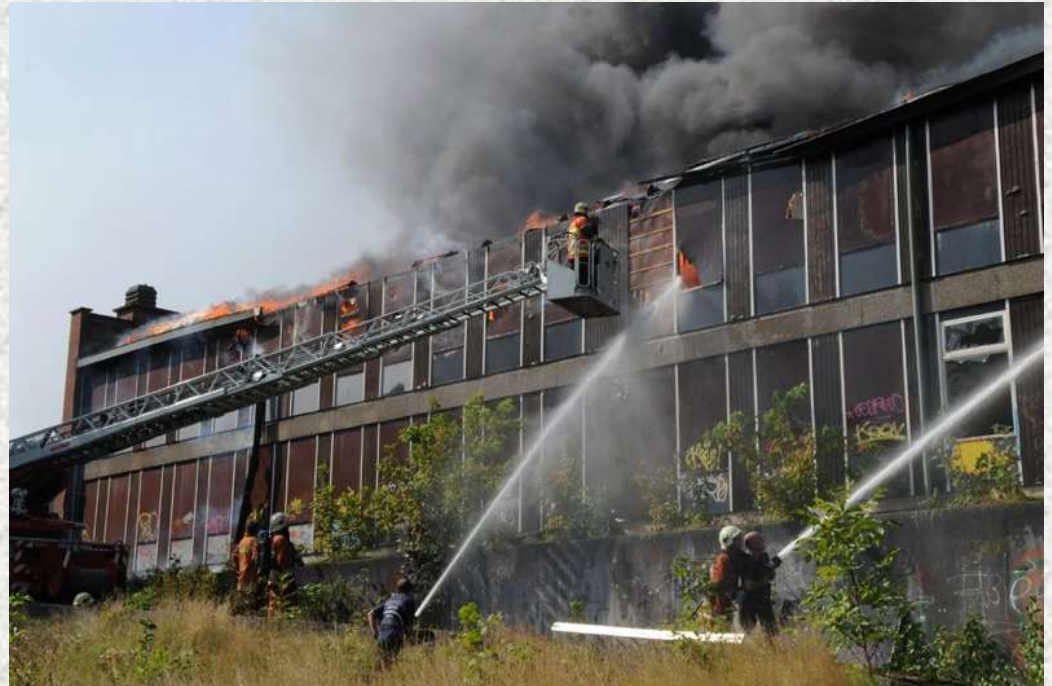
- A captain tried to remove the panels with a crowbar.
- This didn't work because the panels were screwed.
- We did tests afterwards with a rescue saw but that didn't work either because the saw blocked on the insulation.

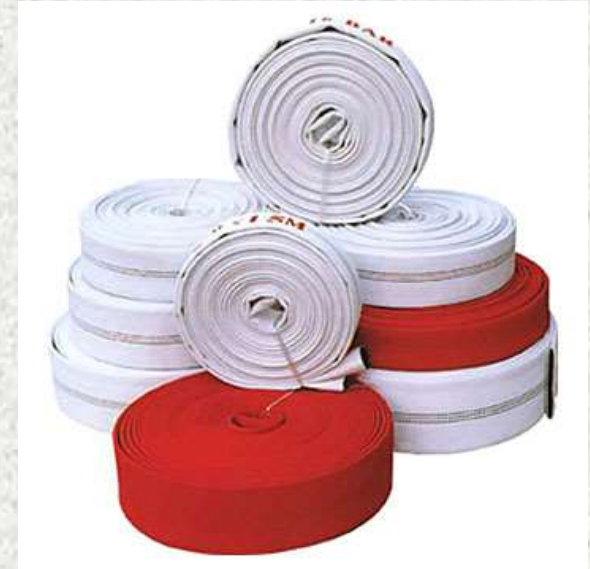
- All of our hoses are rolled.
- It takes time to establish a supply line with rolled hoses.
- We needed more hoses.

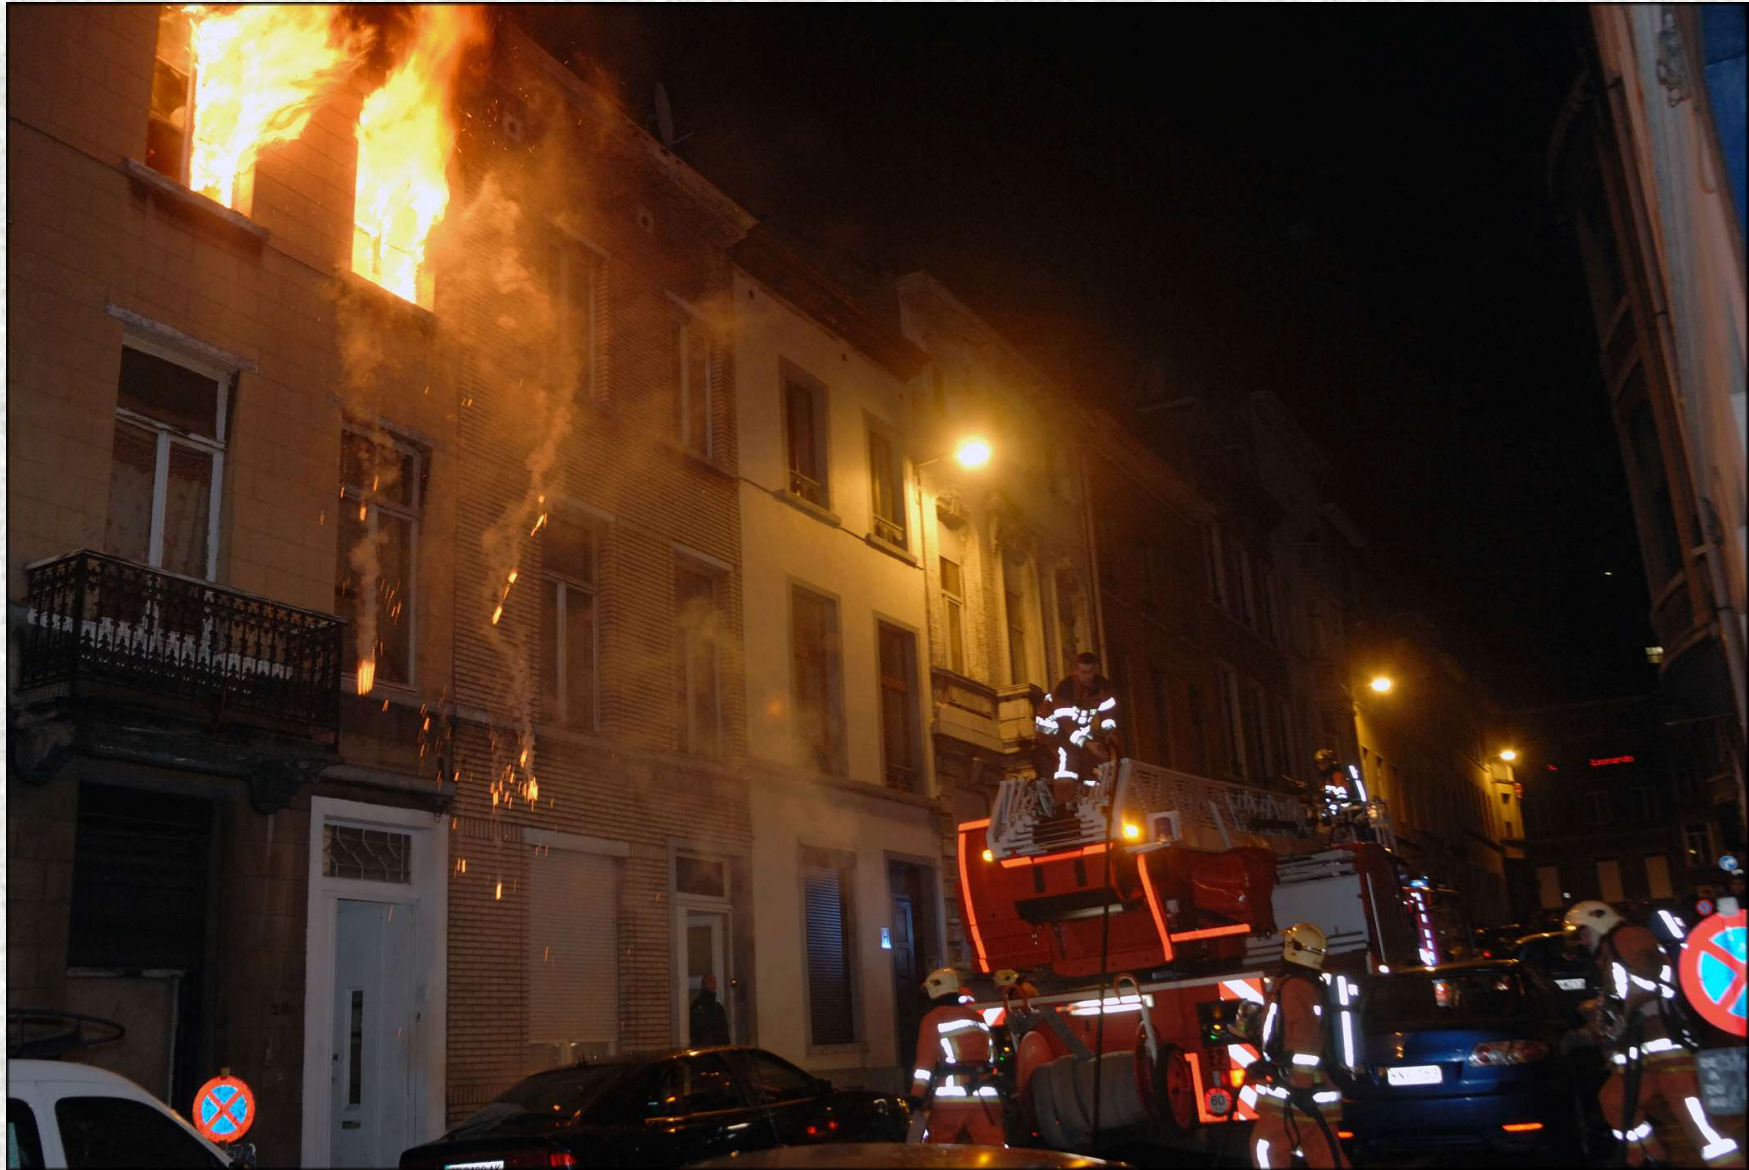
360 ° Reconnaissance?

- In Brussels offensive interior operations is always our first choice.
- This operation actually was “exterior”.
- Most of the time there is no possibility to do a 360 ° reconnaissance.
- A solution could be that we choose to spend more time to do reconnaissance if it is possible.
