# Construction Fire In Brussels: Smoldering fire of polyurethane

## 1 Introduction

## 2 Call for suspicious smoke in Brussels

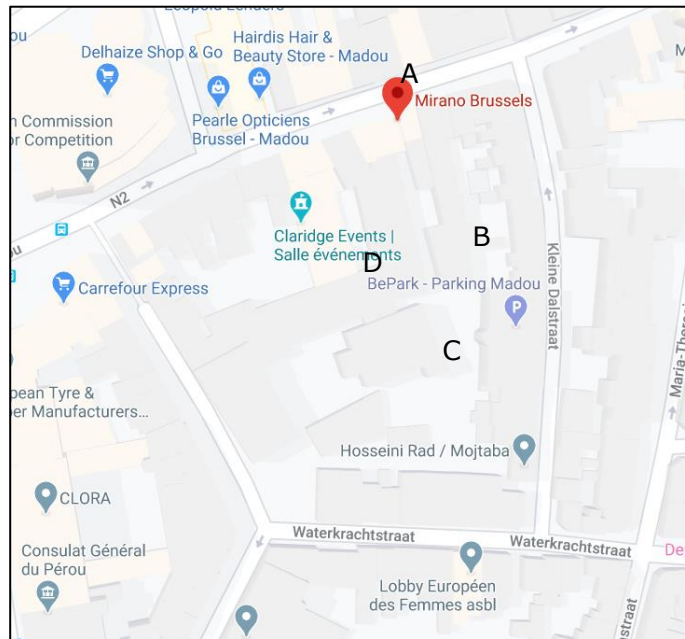
**Image 4** The Leuvensesteenweg is at the upper part of the picture from left to right. The *Mirano* is indicated with the red needle. (source: google maps)

At Charlie-side, there are no adjacent buildings. There is however a medium-rise apartment building at a distance of about 2 meters from the backside of the "Mirano". Image 4 and image 5 show a view of the complexity of this urban situation

The street at Charlie-side, Waterkrachtstraat, is too far away to be of any use. (See image 4).

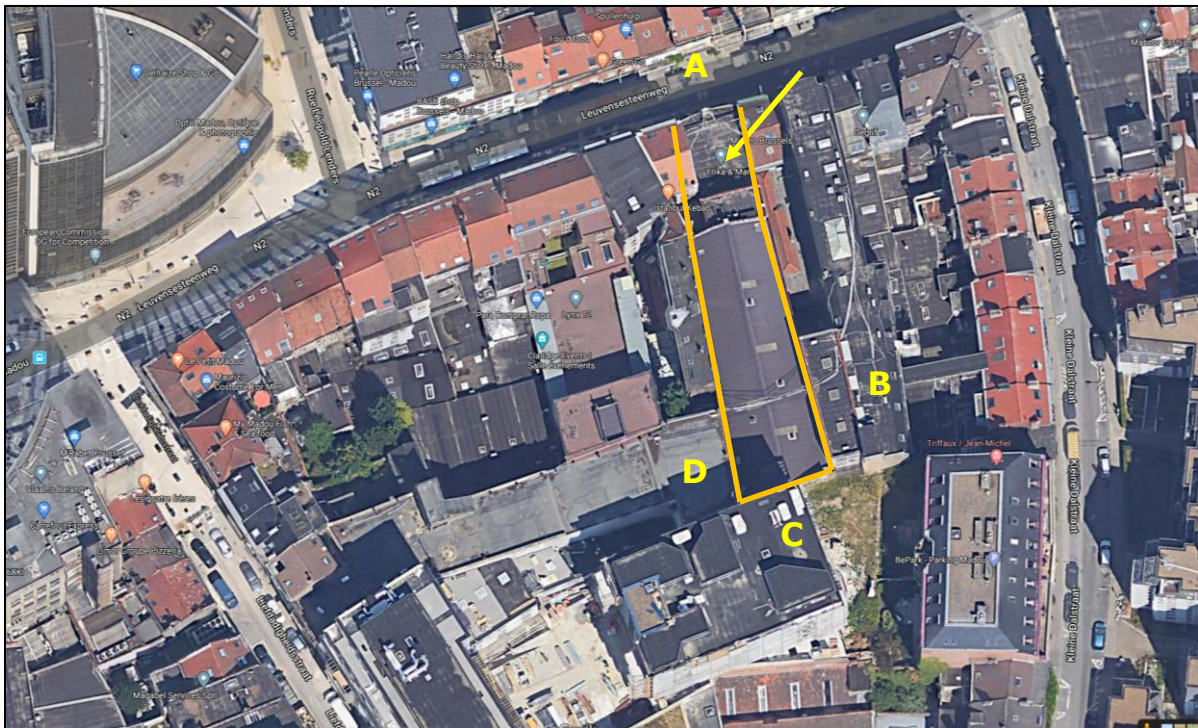
**Image 5** Aerial picture of the buildings around the *Mirano*. The yellow arrow indicates the front part of the building. Underneath the yellow arrow, the rectangular roof of the dancing is visible. (Source: google maps)

The Federal Police Drone Unit was on observing internship with the fire department that day. They came along to the call and had a drone airborne very fast to provide images from above. These images showed the complex structure of the building as visible on image 5. Important in this case is that the gable roof above the attic started only at 20 to 30 meters away from the frontage. It was unreachable for turntable ladder trucks.

Maj. Lambert goes back inside to make a third inspection of the attic. At that moment the inside teams decide that the situation has become too dangerous. The attic was completely filled with smoke by then. Visibility had been reduced to almost zero. The non-commissioned officers inside judge that the risk became too high. The smoke can ignite and the difficult accessibility of the attic ensures that the team inside cannot escape quickly. All firefighters in the attic come back outside. As a result, the great risk for the firefighters has been avoided. (Compared to Diksmuide). However, the firefighting comes to a hold because of this. At this moment during the intervention, no one is working anymore on the fire. After all, there is still no way to get to the roof above the attic. This means that there is a risk for this fire to suddenly spread severely. In this highly urbanized environment (see Image 5), this can get out of hand very quickly.

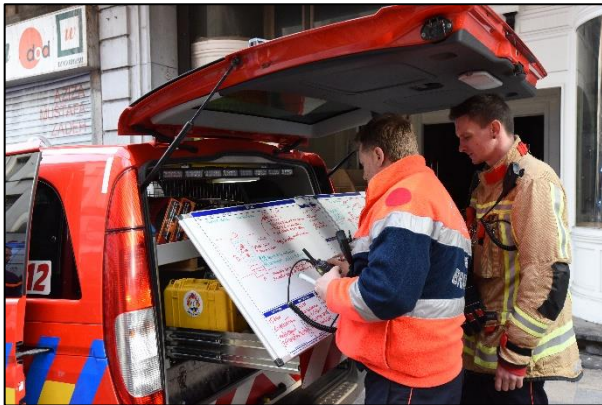
**Image 8** The drivers of both command vehicles use the whiteboards for situational awareness and are following radio communications. (Picture: Robert Decock)

In the meantime, the driver of the command vehicle, Corporal Feytens, made a composition with two whiteboards and tried to make an overview of the situation as good as possible. Upon arrival of the second command vehicle, the driver of it joined him. They start to follow up the firefighters carrying SCBA: Who goes in and comes out and at what times. (Visible at image 8).

During the complete intervention, two people paid attention to the firefighters carrying SCBA (see image 8). This is not something that happens standard in Brussels. Neither is it in the most Belgian Fire Departments due to lack of personnel to fulfill this task. Actually, it is something that should happen every time and extra personnel should be requested for this task in case of a complex intervention.

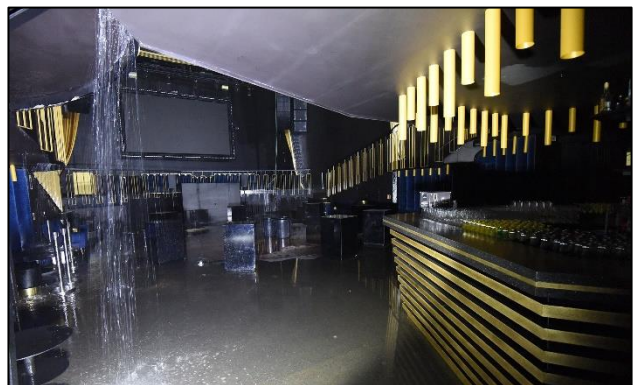
Col. Van Gyseghem applies the cube concept and asks the necessary preparations to be made to prevent the fire from spreading downwards. There is smoke spread downwards after all. Teams are then deployed to first install light in the large room under the attic. Then two fire hoses of 45 mm are laid from the outside to the main hall so that falling, burning parts can be extinguished.

**Image 10** View at the main hall seen from the entrance. (Picture: Robert Decock)
