House Fire – Buffalo, New York

CFBT KNOWLEDGE BASE

Article 2 June 9th, 2004

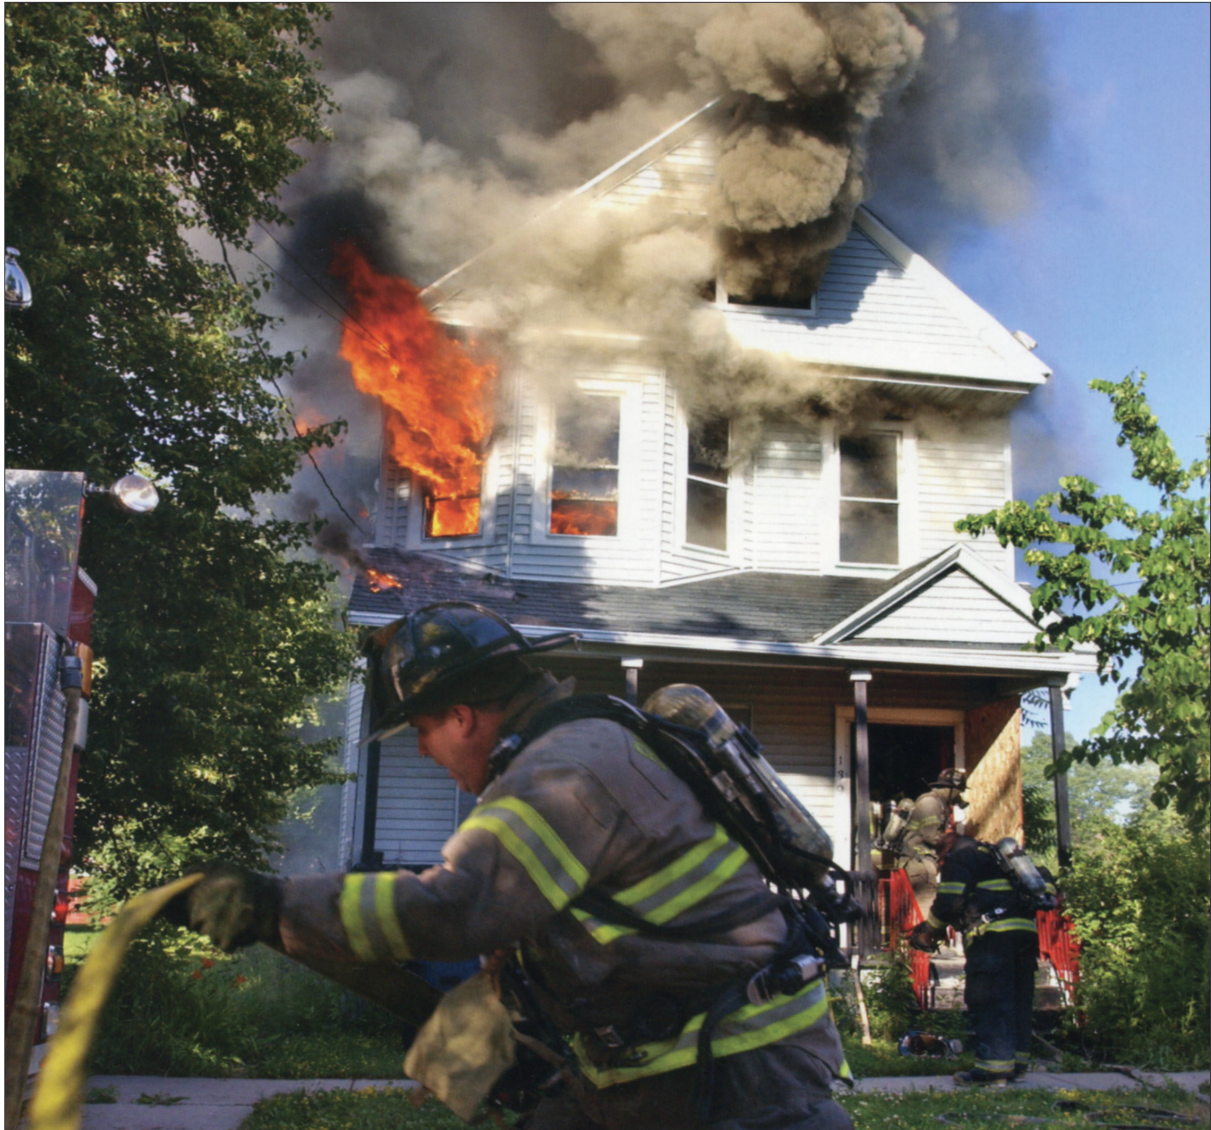
The above picture was on the front cover of Firehouse magazine's March 2004 edition. It is a telling image of the different fire conditions that can be found simultaneously within a single structure. The challenge for all firefighters is to 'read' each situation and then employ the correct tactic and technique.

There is an assumption amongst some firefighters that if we arrive when the building is showing signs of a fully developed fire, we no longer need to worry about Flashover, Backdraught or Fire Gas Ignitions. As we can see with this fire, that is a very dangerous assumption.

We must recognise that adjoining rooms will, if conditions of fuel and ventilation allow, Flashover in turn as the fire advances through the structure. Similarly, hot fire gases can collect within the structure awaiting the addition of air or ignition source, posing the danger of a Backdraught or Fire Gas Ignition. To remain safe in such a structure, firefighters must rely on all of their fire behaviour knowledge and 'gas cooling' techniques.

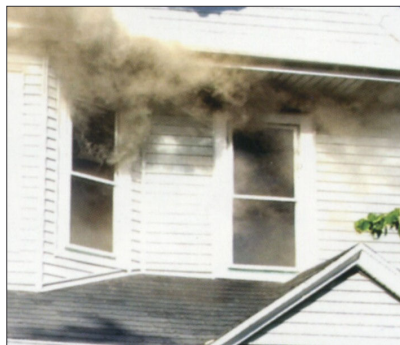
2nd Floor – Pre Flashover Conditions

This room shows hot fire gases banking down from the ceiling. It appears that these gases have come from the adjoining room prior to it reaching Flashover (see below). Within this room all combustibles exposed to these hot gases would be pyrolysing and adding to the flammable atmosphere. This room could be moments from Flashover with the adjoining room providing heat, fire gases and an ignition source.

This is an extremely dangerous situation for internal crews about to launch an attack on the fully developed room adjoining. Crews **MUST** make this room safe with aggressive gas cooling techniques prior to attacking the fire in the adjoining room. Failure of the room's windows at this stage (either by accident or design) could bring about Flashover with the advent of more oxygen and a 'leaning' out of the flammable mixture inside.

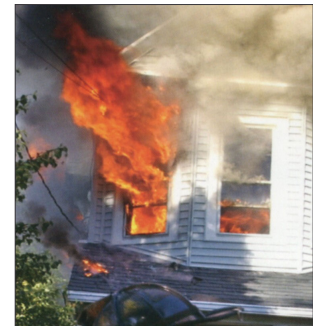
2nd Floor – Fully Involved Room

This room has 'flashed over' and is now fully developed. The open windows are providing ventilation for the fire to continue in this state. There is relatively little smoke issuing and the fire is burning at its most intense.

No person can survive in this area and the most efficient extinguishing technique would be an 'indirect' attack launched from the interior doorway.

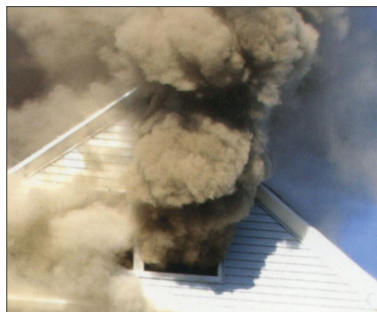
Attic – Under Ventilated Room

This room is receiving large volumes of heated fire gases from below. The lack of visible flame and the billowing smoke escaping from the attic window under pressure, is clear evidence of an under-ventilated compartment.

A danger exists if these fire gases are able to mix with oxygen and achieve a flammable state. At present they are probably too rich to ignite. If this pressure eased off and more air is able to mix with these gases, a flammable state could then exist. It may or may not need an ignition source to ignite.

Crews will need to stop the production of these fire gases (extinguish the fire below) and then cool and dilute the gases in this compartment before entry; always aware of any ignition sources that may be present.
